## 6.16 Industrial Site, Australia

An industrial site in Australia was used for the manufacture of 1,2-dichloroethane in the 1960s. In 1969, a grassfire engulfed a drum store containing hundreds of drums of chlorinated hydrocarbon byproducts, resulting in contamination of a fractured basalt aquifer and a groundwater contaminant plume that is intercepted by a deep, leaky sewer approximately 2 km away. The groundwater is naturally saline (TDS >8,000 mg/L) and is not used for drinking, irrigation, or stock watering.

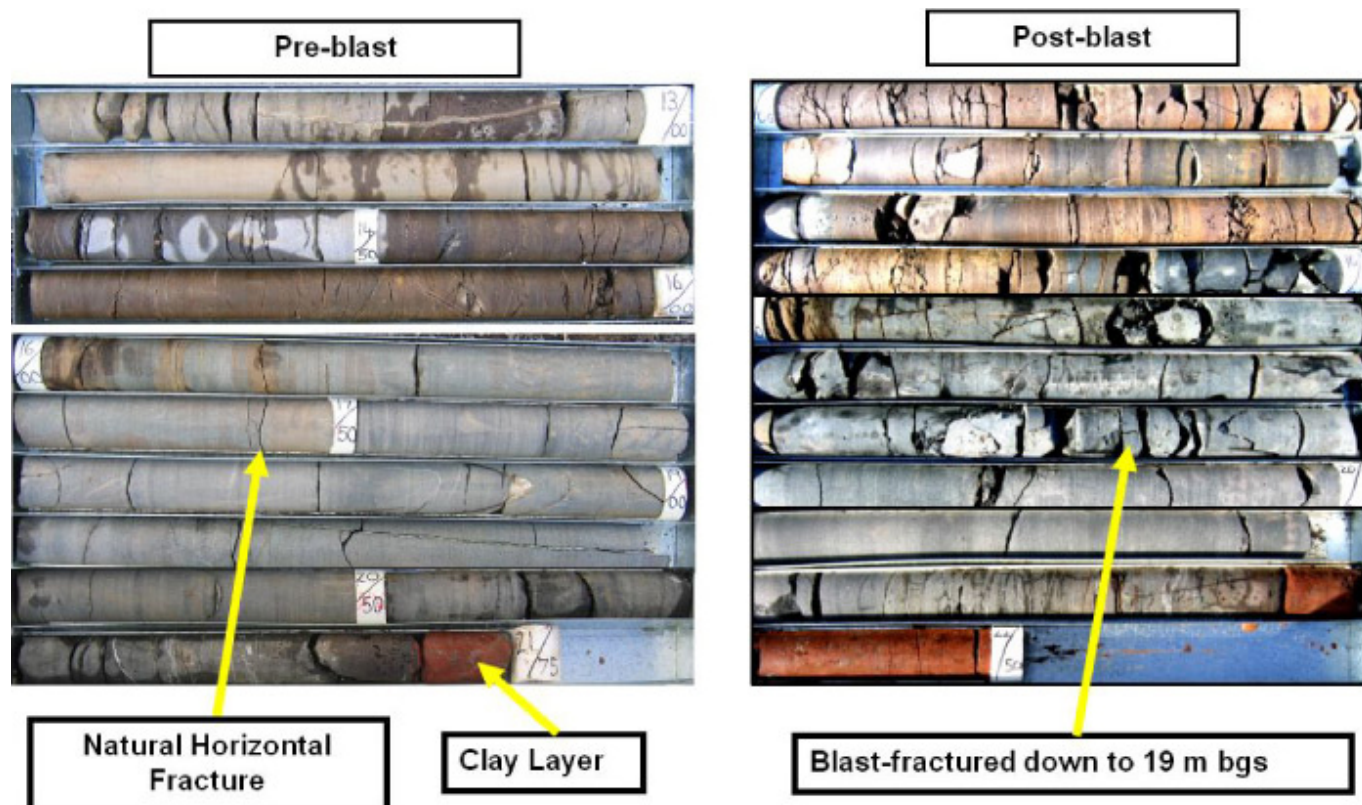
Figure 68 shows typical preblast and postblast basalt cores in the main source area. Note that fractures appear to be predominantly near-horizontal, with some vertical fracturing, together with an underlying clay layer at the base of the basalt flow. Blast designs aimed to avoid disrupting this clay layer by leaving a 2-m buffer of nonblasted basalt above it, based on blasting experience at local basalt quarries. Effective porosity was assumed to be 1% for estimating pore volumes.

**Figure 68. Typical preblast and postblast basalt cores** (Goodwin et al. 2010).

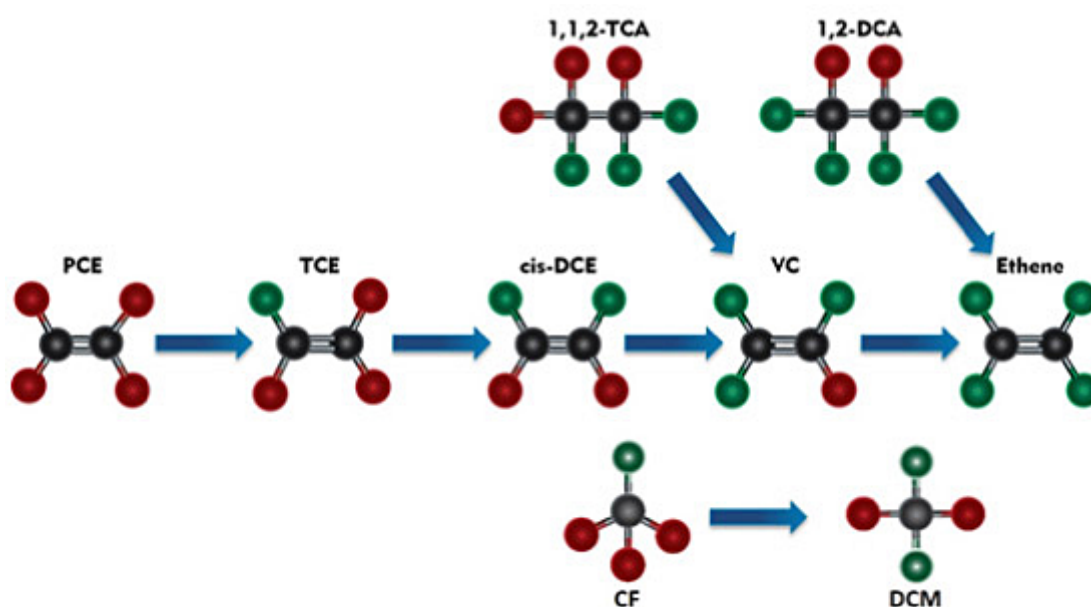
Figure 70 shows key microbial degradation pathways for the chlorinated ethanes, ethenes, and methanes identified at the site ([Ogles et al. 2014](#), [Ogles et al. 2015](#)). The site assessment concluded that the high concentrations of VC measured in parts of the source area were due primarily to dichloroelimination of 1,1,2-TCA and the high ethene concentrations were due primarily to dichloroelimination of 1,2-DCA. Chloroform is a potential inhibitor for biodegradation of cis-1,2-DCE and VC.

**Figure 70. Biodegradation pathways and potential chloroform inhibition at the site** ([Ogles et al. 2014](#), [Ogles et al. 2015](#)).

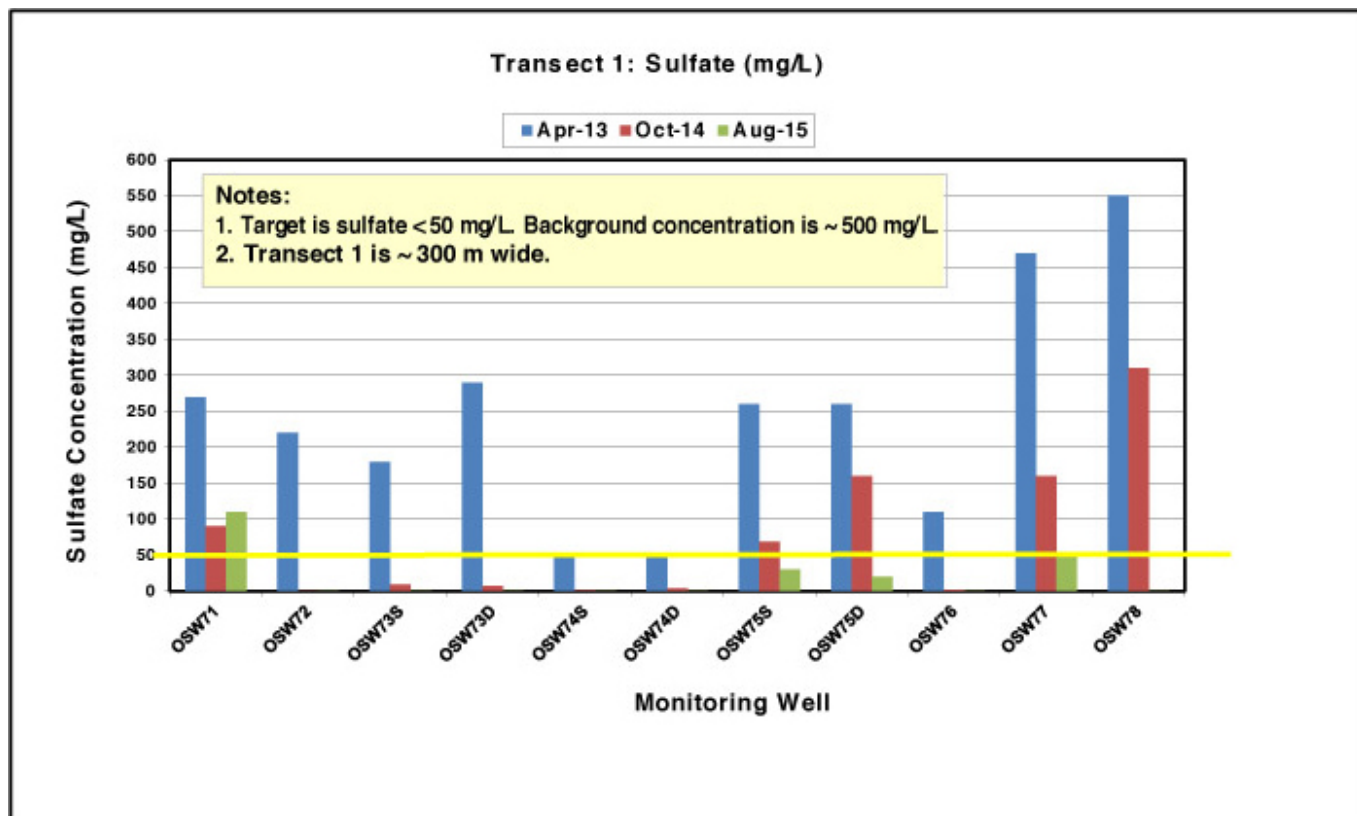
Monitoring at Transect 1, (300 m wide and located approximately 100 m downgradient from the center of the source zone), continues to track performance of the source area EISB system. Figure 71 shows development of sulfate reducing conditions, from an initial background of 550 mg/L sulfate, while Figure 72 shows development of *Dehalococcoides*, and Figure 73 shows vinyl chloride reductase (*vcrA*) which indicates the potential for biodegradation of vinyl chloride to ethene. These charts track expansion of the biodegradation zone downgradient to Transect 1. Ongoing monitoring indicates that the biodegradation zone continues to expand down-hydraulic gradient, beyond Transect 1.

**Figure 71. Sulfate concentration across Transect 1 (immediately downgradient from source area)** ([Confidential source 2017](#)).

Amendment delivery to treatment zones is critical for in situ remediation systems. Figure 71 through Figure 73 indicate most wells across a 300 m wide transect met proposed operating targets for sulfate, *Dehalococcoides*, and *vcrA* by August 2015. The differing times required appear to be related to initial chloroform concentrations and differing VFA migration rates downgradient, consistent with the inherent heterogeneity of the basalt aquifer in and down-hydraulic gradient from the source zone.

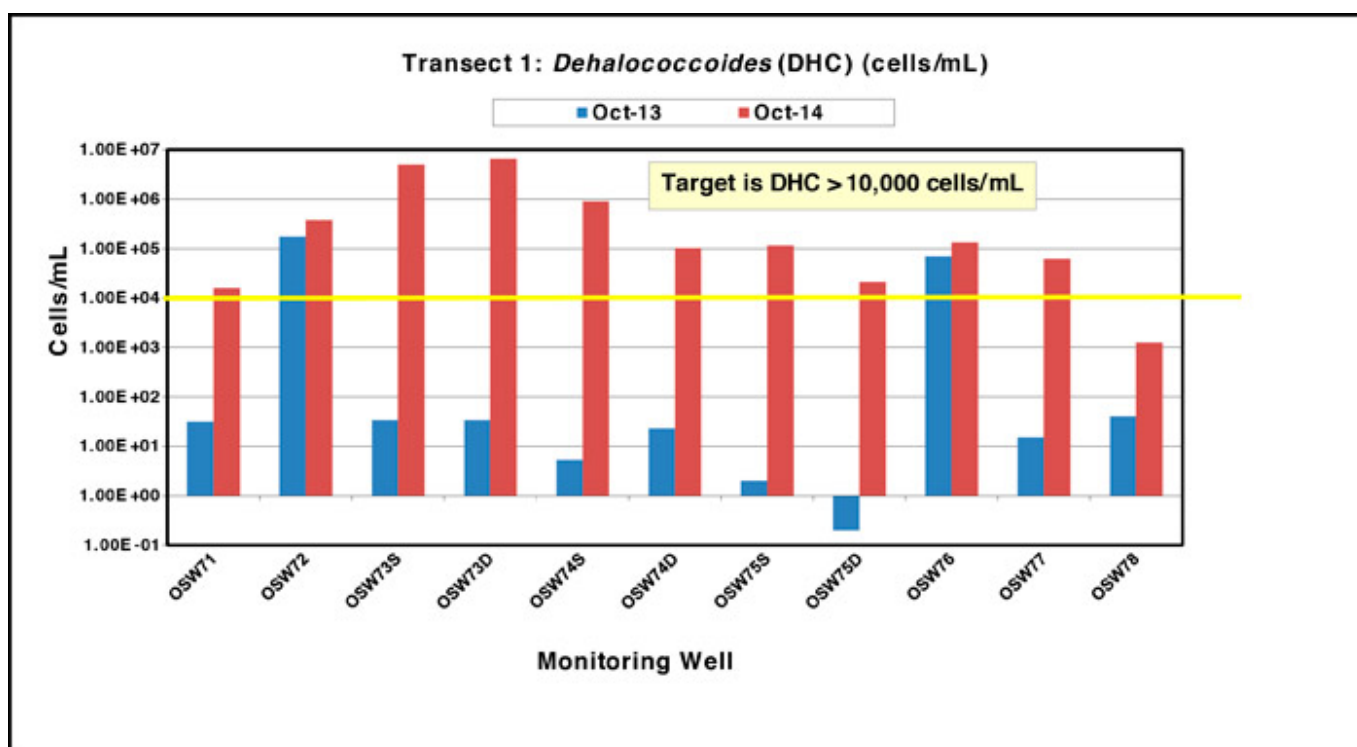
**Figure 72. *Dehalococcoides* (DHC) across Transect 1 (cells/mL)** ([Confidential source 2017](#)).

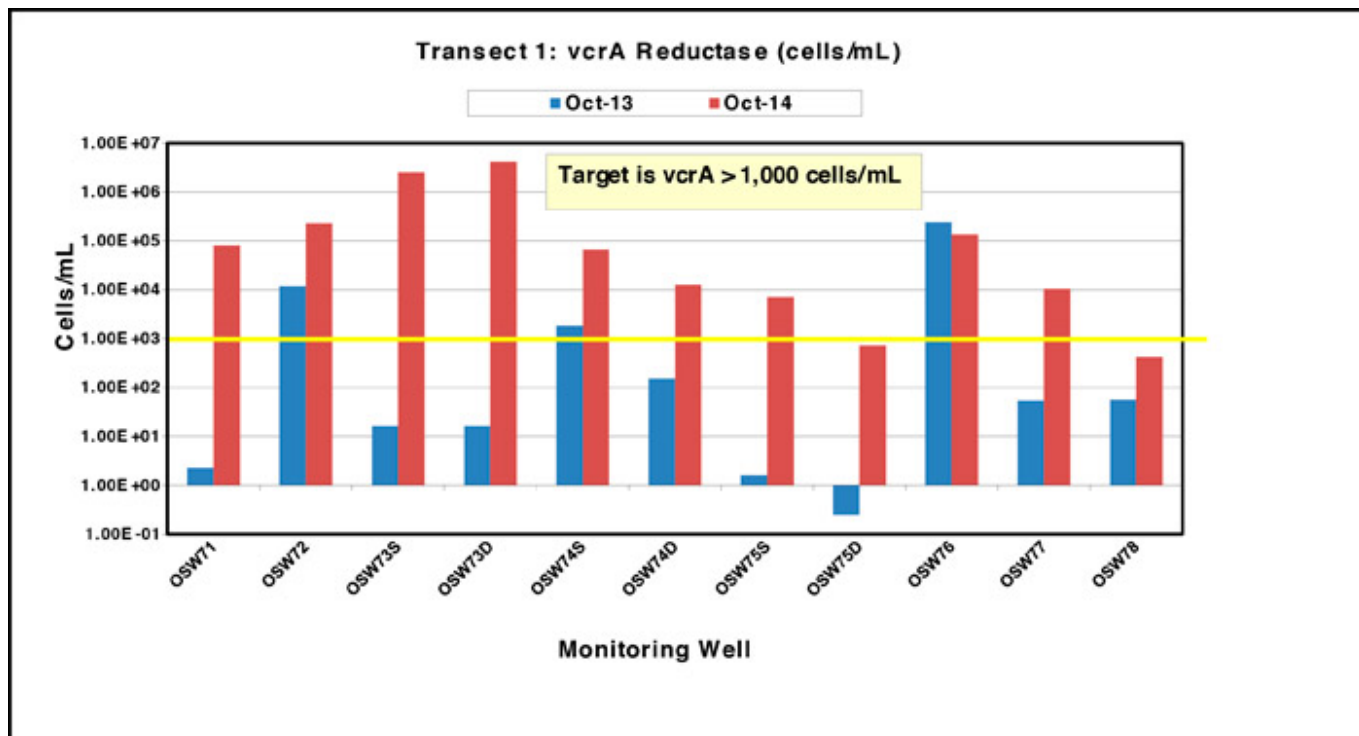
**Figure 73. Vinyl chloride reductase gene copies (vcrA) across Transect 1 (cells/mL)** ([Confidential source 2017](#)).

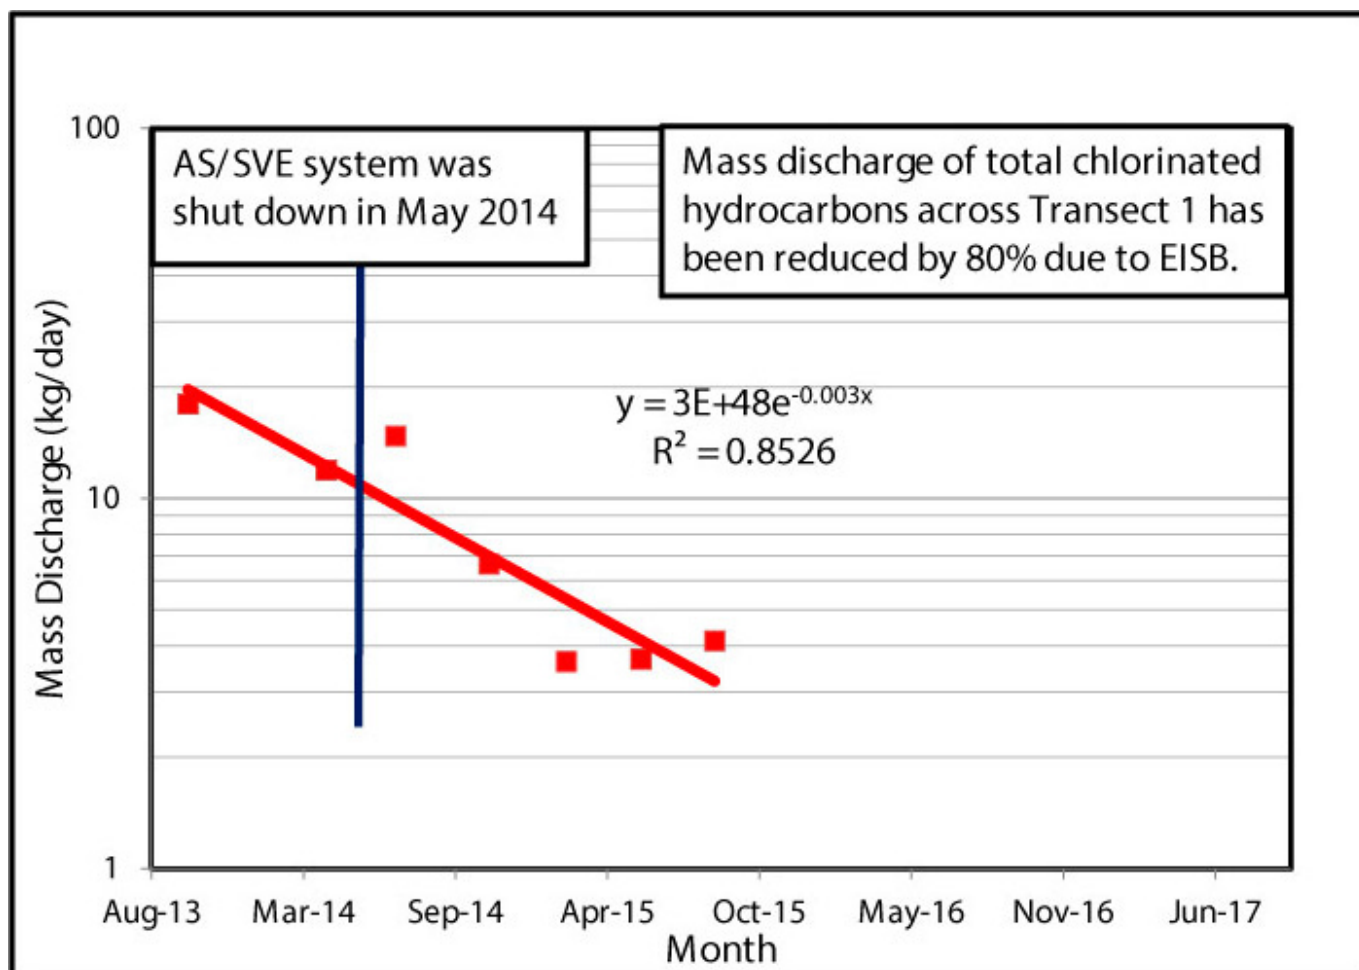
Notably, the estimated mass discharge of total chlorinated VOCs from the source area, measured at eight groundwater monitoring wells over a 300 m wide transect, decreased by 80% over a two-year period, as shown in Figure 74. Mass discharge reductions for parent compounds 1,1,2-TCA and 1,2-DCA were even greater.

**Figure 74. Mass discharge of total chlorinated hydrocarbons (Transect 1)** ([Baldwin et al. 2017](#)).

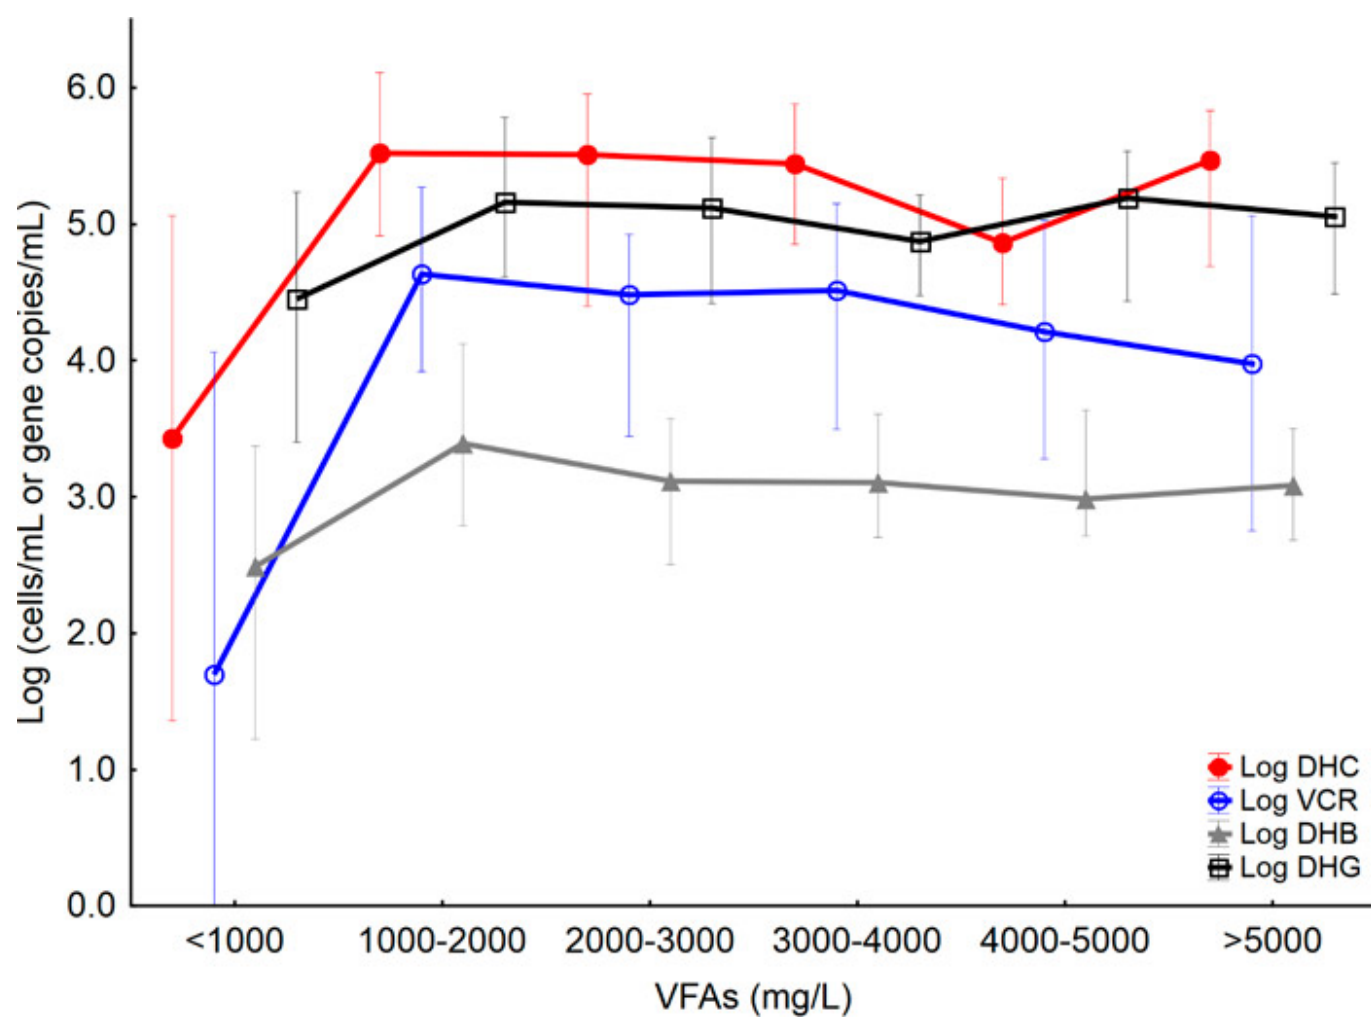
To characterize the operational performance of the EISB system, rather than attempting high resolution site characterization (which was considered impractical in this highly heterogeneous basalt aquifer), over 250 source area groundwater samples were analyzed by qPCR or QuantArray, and statistical analysis was conducted to identify and evaluate key process variables for operating the EISB system. Many groundwater samples from source and plume areas were also analyzed by CSIA to assess degradation and attenuation processes. This assessment allowed the key operating variables to be identified (total volatile fatty acids, sulfate, and chloroform concentrations) as shown in Figure 75 through Figure 77 below.

**Figure 75. Statistical analysis, key dechlorinating microbes (*Dehalococcoides* (DHC), *Dehalobacter* (DHB), *Dehalogenimonas* (DHG) spp. and vinyl chloride reductase (VCR)), versus total volatile fatty acids (VFAs)**  
([Baldwin et al. 2017](#)).

Based on the statistical analysis of key dechlorinating microbes, for this particular EISB system, PG injections were effective when the total VFA concentration was >1,000 mg/L and sulfate concentration was <50 mg/L. Even with adequate electron donor and geochemical conditions, chloroform concentrations >4 mg/L inhibited growth of *Dehalococcoides* populations. The EISB area continues to expand down and cross hydraulic gradient (as evidenced by migration of total VFAs, microbes, declining sulfate concentrations, and increased ethene concentrations) and a key objective is to achieve further mass discharge reductions from the source area. Once mass discharge across Transect 1 has been reduced to a minimum practical level, it is proposed to progressively modify/optimize operation of the source area EISB to sustain minimum mass discharge levels.

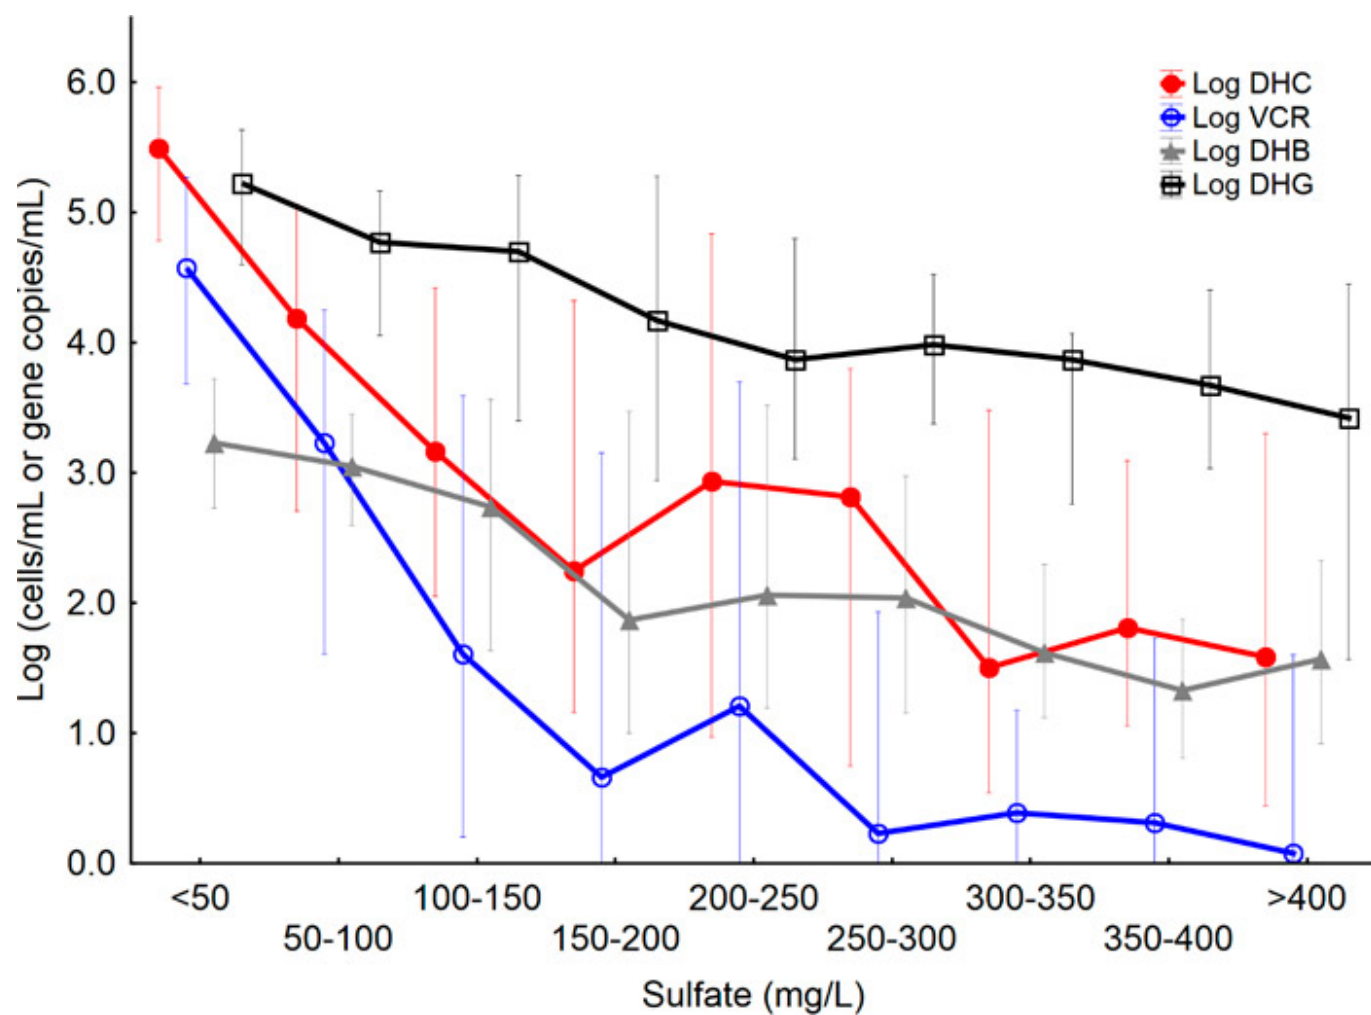
Figure 76. Statistical analysis, key dechlorinating microbes (*Dehalococcoides* (DHC), *Dehalobacter* (DHB), *Dehalogenimonas* (DHG) spp. and vinyl chloride reductase (VCR)), versus sulfate (Baldwin et al. 2017).

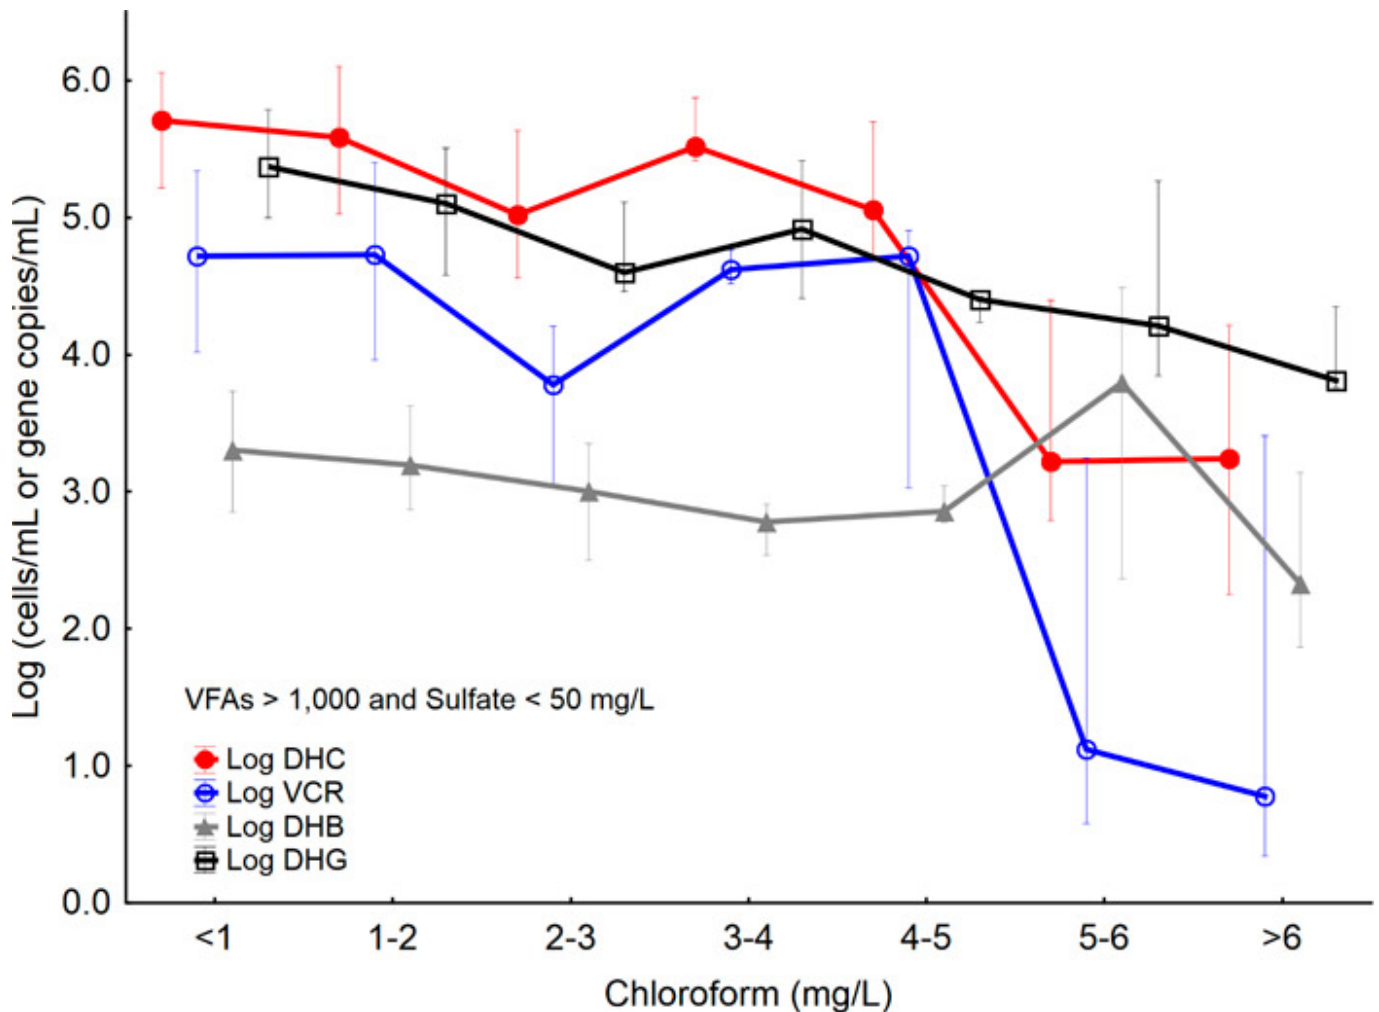
**Figure 77. Statistical analysis, key dechlorinating microbes (*Dehalococcoides* (DHC), *Dehalobacter* (DHB), *Dehalogenimonas* (DHG) spp. and vinyl chloride reductase (VCR)), versus chloroform (Baldwin et al. 2017).**
