Printed from: Interstate Technology & Regulatory Council (ITRC). 2017. *Remediation Management of Complex Sites*. RMCS-1. Washington, D.C.: Interstate Technology & Regulatory Council, Remediation Management of Complex Sites Team. <http://rmcs-1.itrcweb.org>.

## 6.1 Koppers Oroville Wood Treatment Facility, California

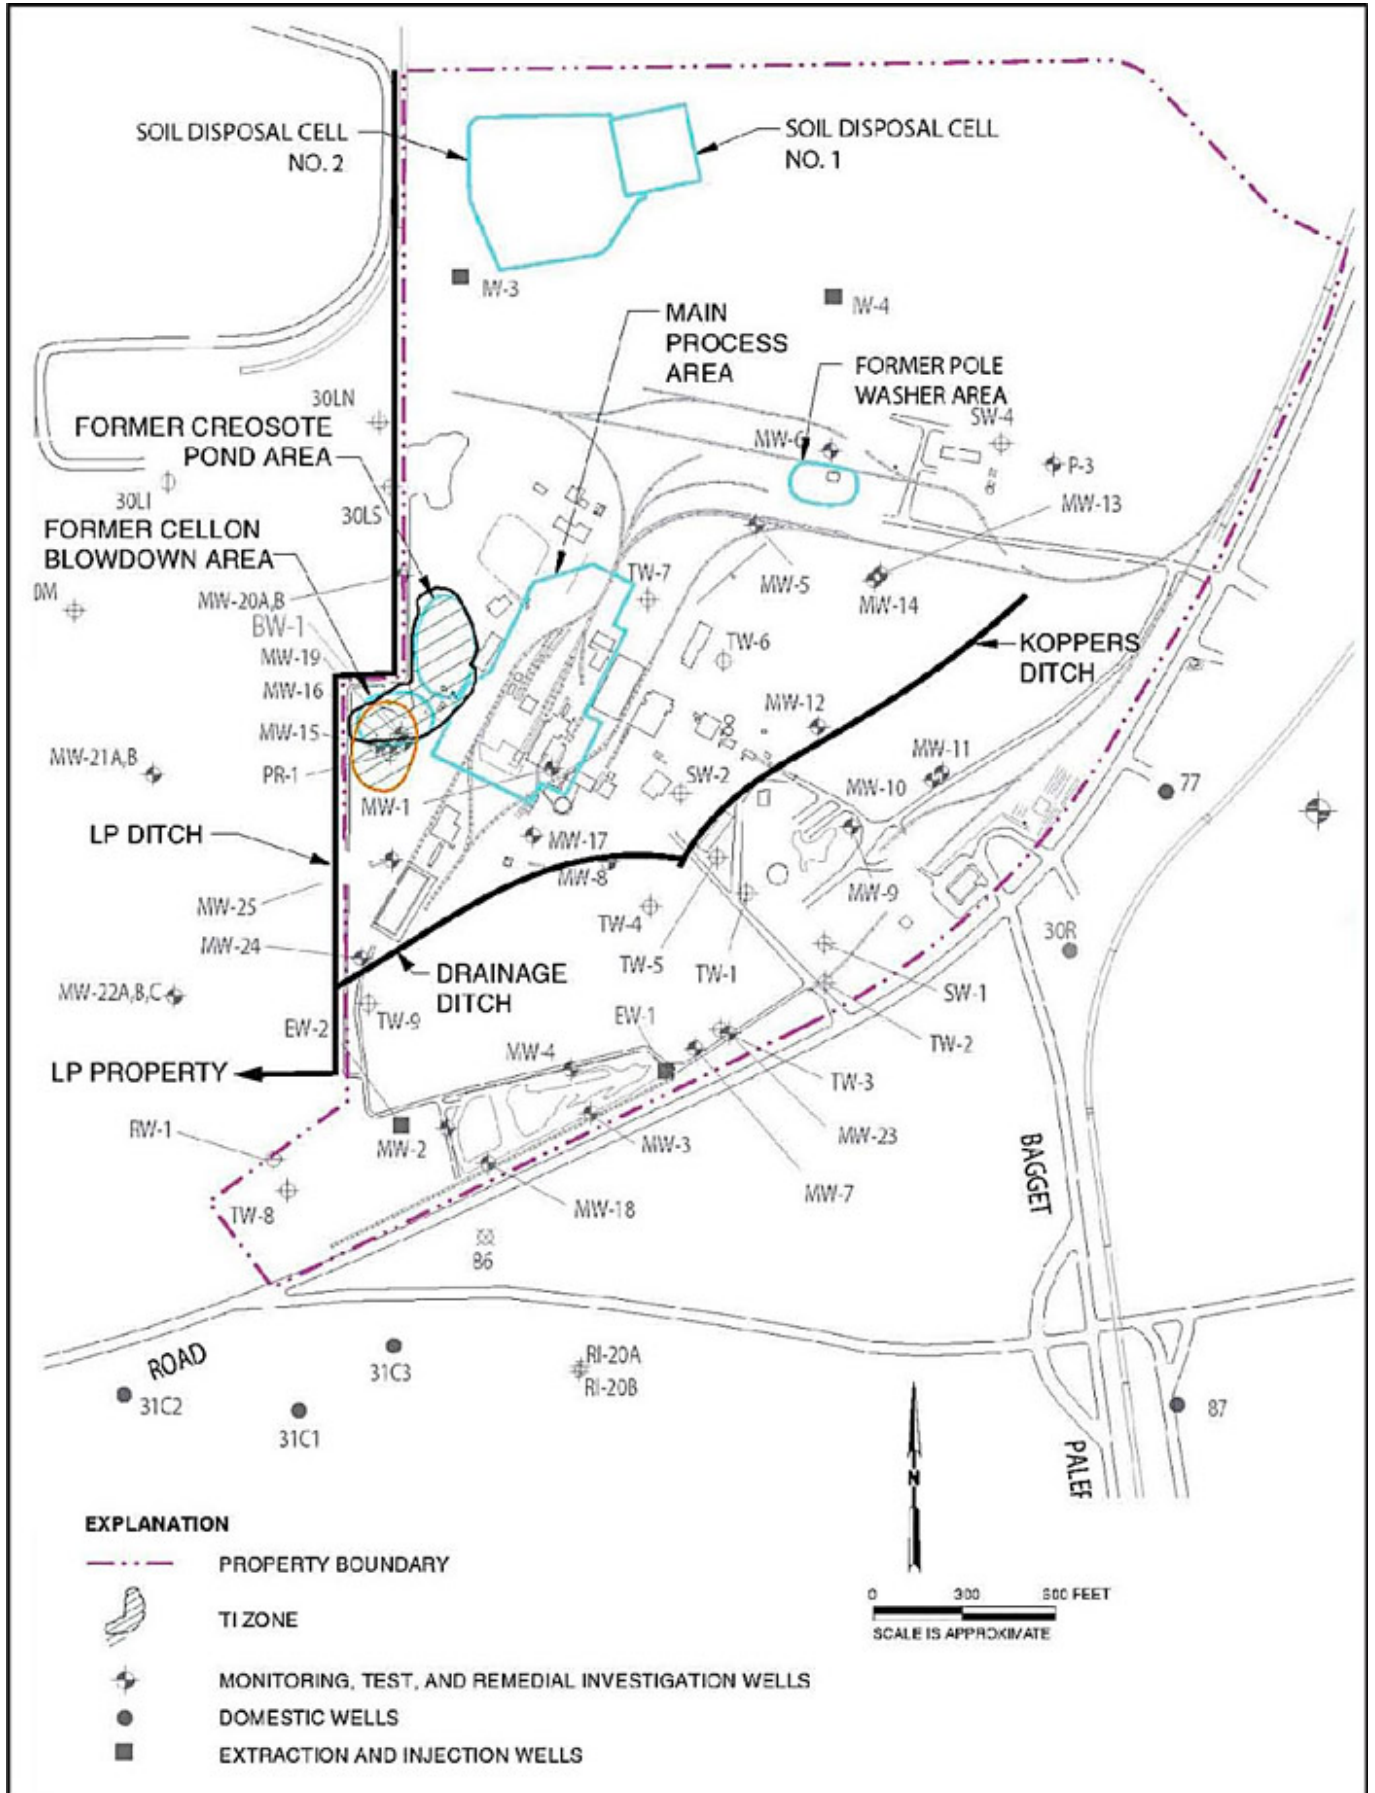
**Figure 7. Site features, former Koppers Oroville Wood Treatment Facility (USEPA 2013a).**

The Koppers Oroville site is a former wood treating facility that operated from 1948 until it closed in 2001. The site occupies approximately 205 acres in Butte County, California, near the City of Oroville (Figure 7). The site is bounded by the former Louisiana-Pacific Lumber Mill to the west, Georgia Pacific Way to the north, and Bagget-Marysville Road to the south and east. Land use surrounding the site is a mixture of residential, industrial, and agricultural uses. As of 2015, approximately 10,650 people lived within a three-mile radius of the site and rely on groundwater as their source of drinking water.

The main areas of operation at the site (Figure 7) included a wood processing area (main process area) and creosote settling ponds. From 1961 until 1973, blowdown from a Cellon wood treatment process was released into about an acre near the western site boundary (Cellon blowdown area). In 1963, a pole washing unit was installed in the northern portion of the plant site. From 1963 through 1973, equipment was used to spray a solution of water and sodium hydroxide on the Cellon-treated poles to both remove excess pentachlorophenol (PCP) from the pole surface and to prevent formation of PCP crystals on the wood surface. Wastewater from the process was not contained, and much of this wastewater flowed to a small depression just south of the pole washer.

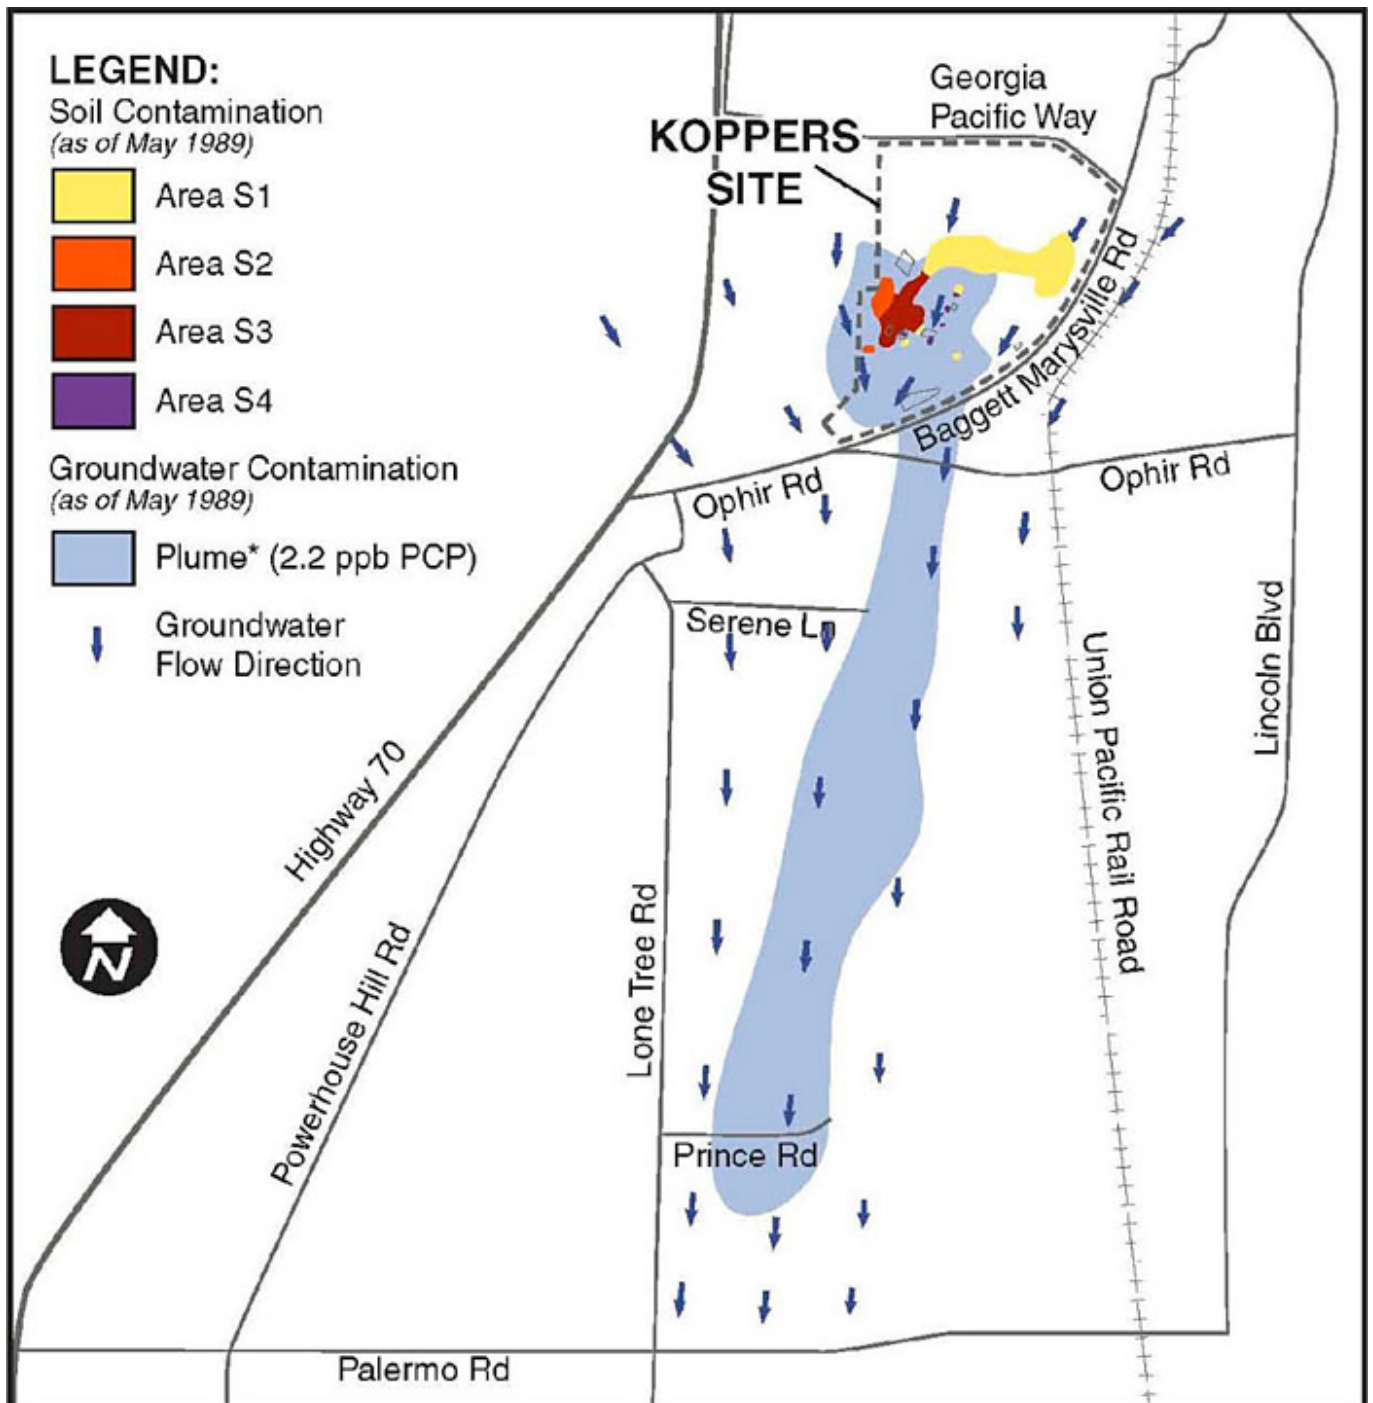
Figure 8. Soil and groundwater units, former Koppers Oroville Wood Treatment Facility (USEPA 2013a).

The remedy for the site was described in the original 1989 ROD, 1991 ESD, and ROD Amendments 1 and 2 (1996 and 1999). Four soil operable units, OU S1 through OU S4 were designated (Figure 8), as well as two groundwater units: on-property and off-property. Cleanup standards for soil were based on direct contact with surface soil and were set to residential standards. The ESD provided separate cleanup standards for subsurface soil to protect underlying groundwater. Cleanup goals for groundwater were established as MCLs for PCP, total carcinogenic PAHs, dioxins/furans, and background levels for arsenic

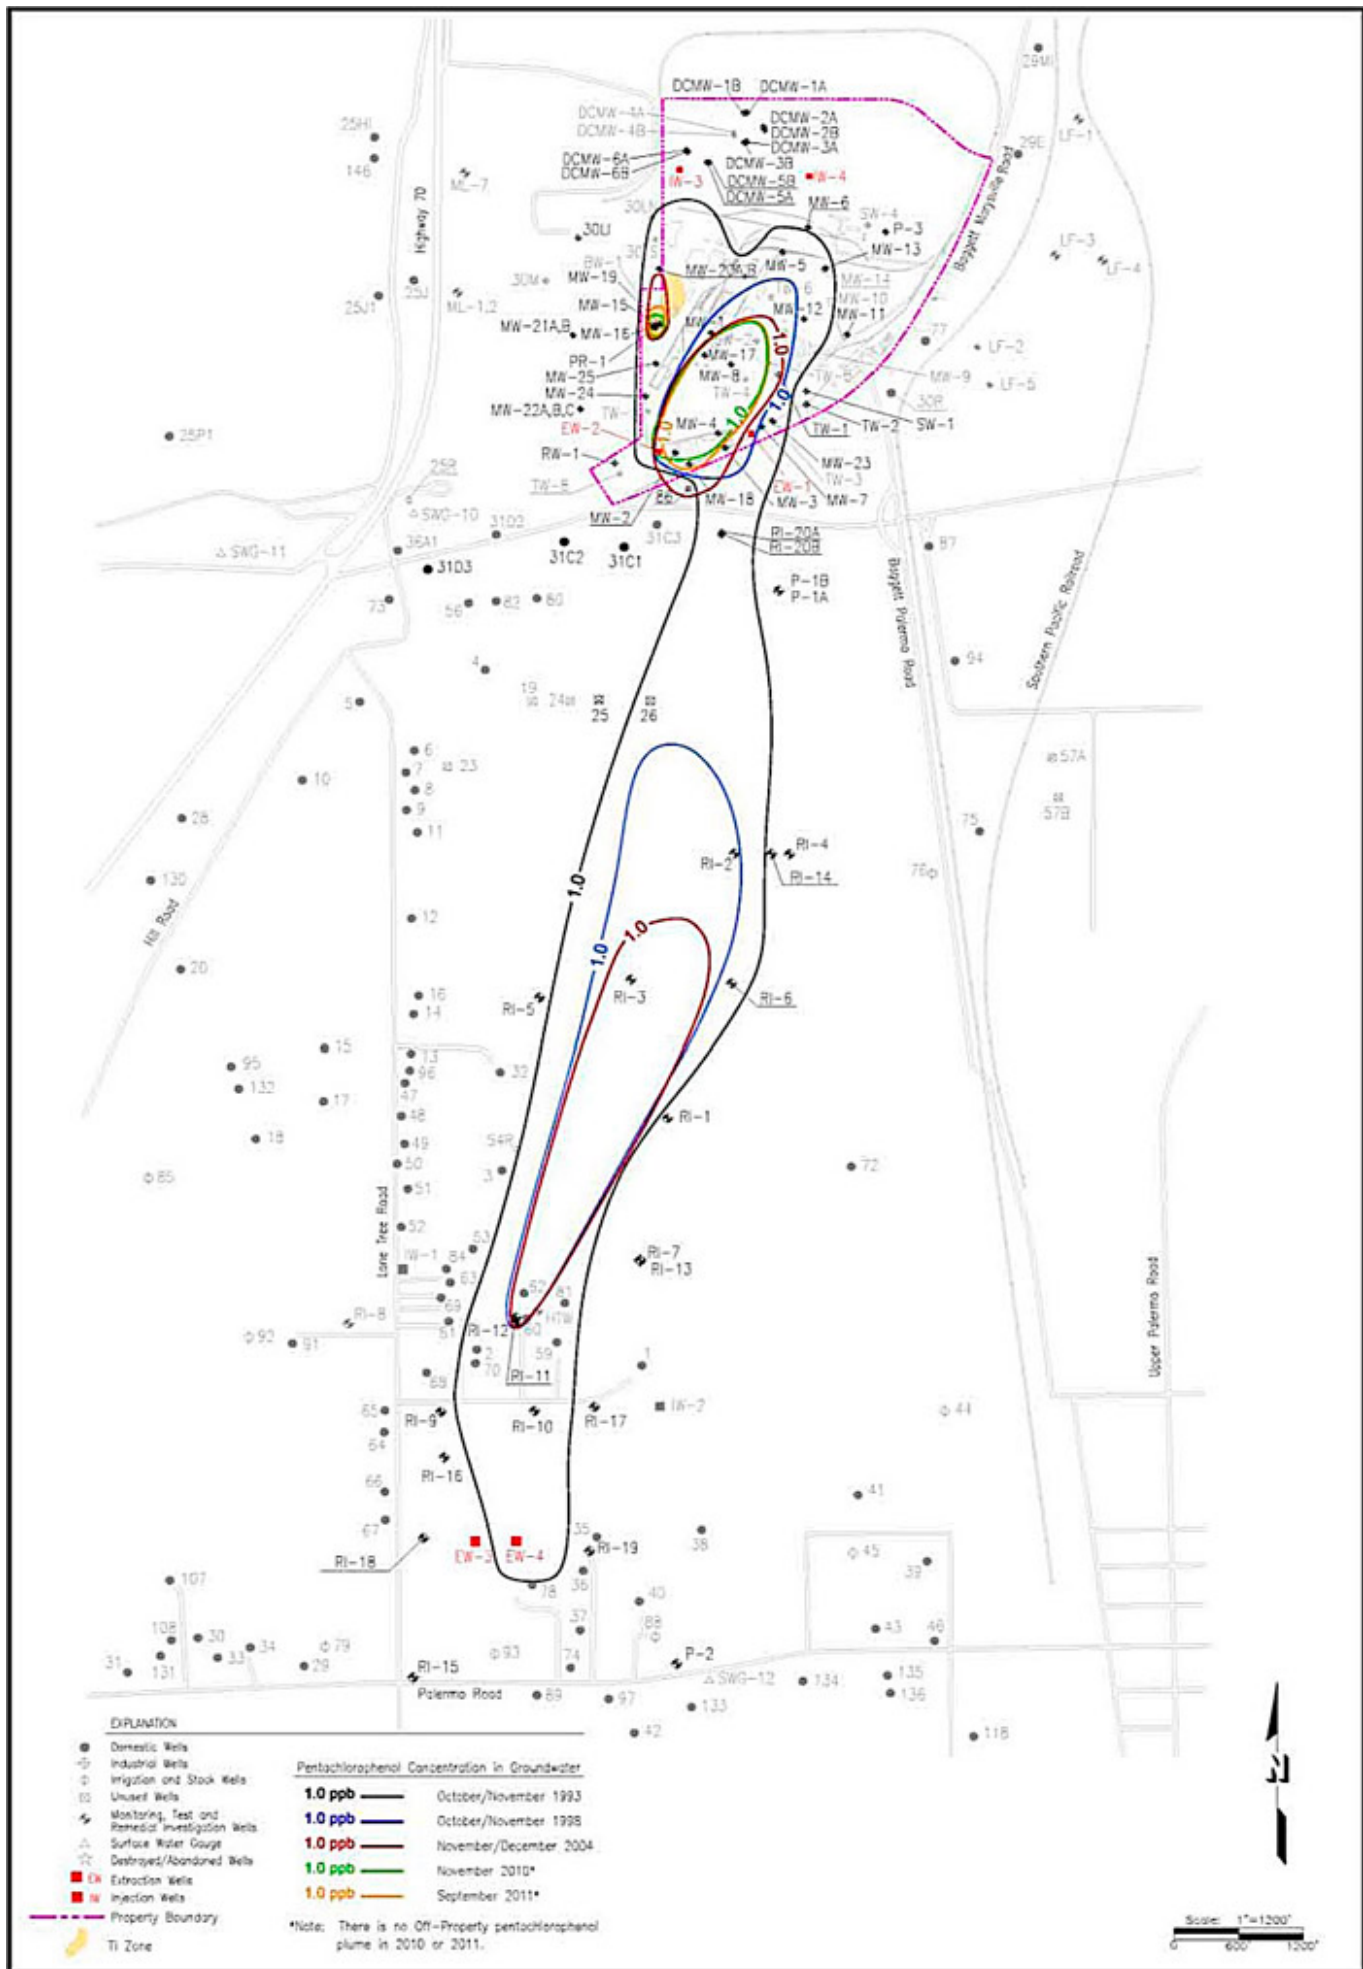
**Pentachlorophenol Concentration in Groundwater**

**Figure 9. On property and off property PCP plume, comparison from 1993 through 2011 for the former Koppers Oroville Wood Treatment Facility**  
(USEPA 2013a)

An off-property groundwater treatment system was installed south of Prince Road (Figure 9). Two extraction wells (EW-3 and EW-4) were installed at the toe of the two-mile plume (Figure 9) along with a treatment plant, two injection wells, and approximately 1,500 feet of pipelines. Initially, treated water was discharged to Wyman Ravine. Later, this water was reinjected upgradient of the off-property plume into injection wells IW-1 and IW-2. The P&T system was shut down in December 1995 and dismantled in 2007, after monitoring indicated that the plume had retreated upgradient of the extraction wells. During its operation, the system treated over 626 million gallons of contaminated groundwater.
