Printed from: Interstate Technology & Regulatory Council (ITRC). 2017. *Remediation Management of Complex Sites*. RMCS-1. Washington, D.C.: Interstate Technology & Regulatory Council, Remediation Management of Complex Sites Team. <http://rmcs-1.itrcweb.org>.

6.1 Koppers Oroville Wood Treatment Facility, California

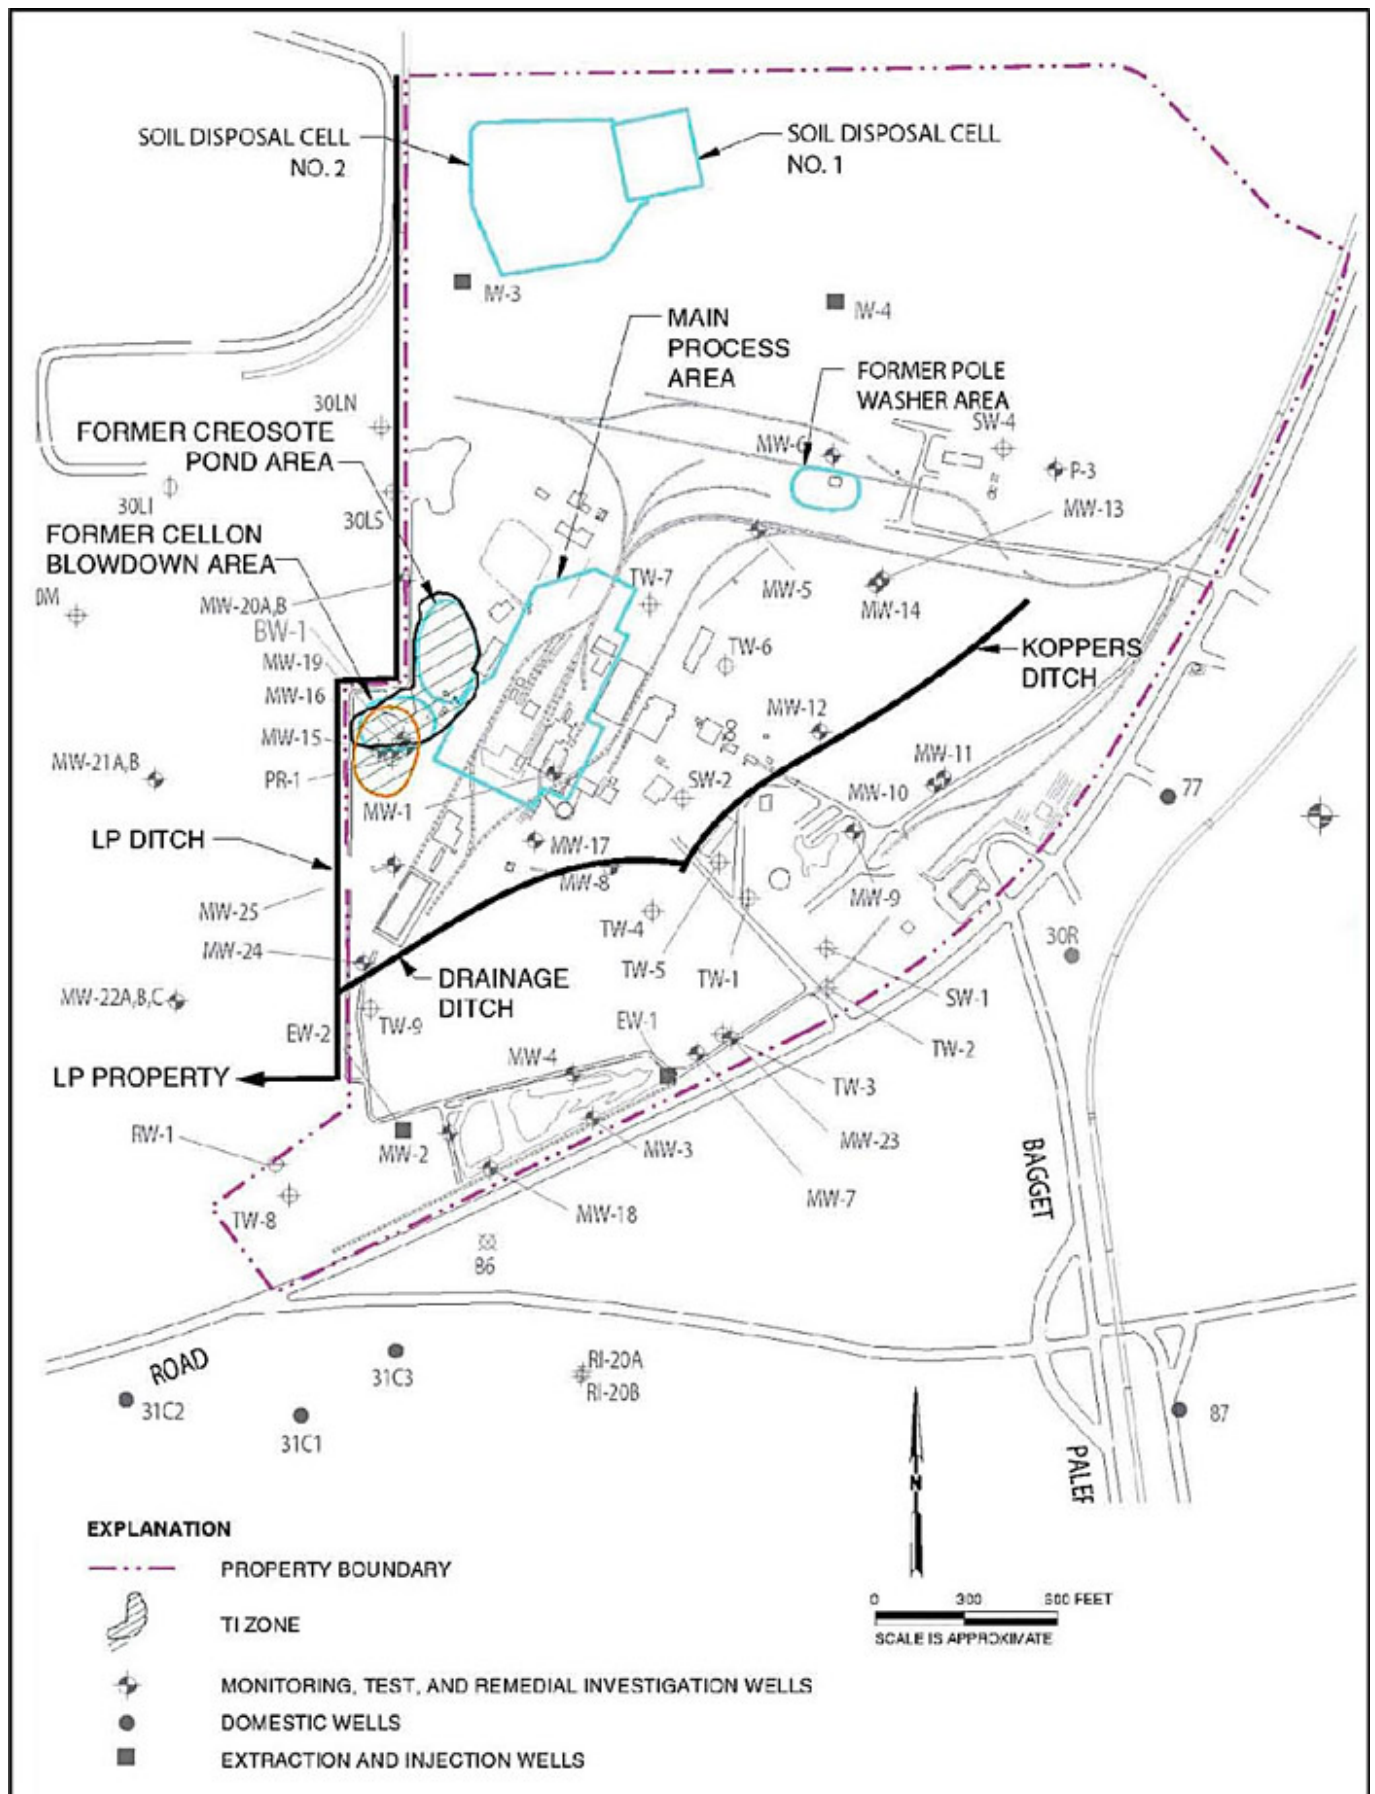
Figure 7. Site features, former Koppers Oroville Wood Treatment Facility (USEPA 2013a).

The Koppers Oroville site is a former wood treating facility that operated from 1948 until it closed in 2001. The site occupies approximately 205 acres in Butte County, California, near the City of Oroville (Figure 7). The site is bounded by the former Louisiana-Pacific Lumber Mill to the west, Georgia Pacific Way to the north, and Bagget-Marysville Road to the south and east. Land use surrounding the site is a mixture of residential, industrial, and agricultural uses. As of 2015, approximately 10,650 people lived within a three-mile radius of the site and rely on groundwater as their source of drinking water.

The main areas of operation at the site (Figure 7) included a wood processing area (main process area) and creosote settling ponds. From 1961 until 1973, blowdown from a Cellon wood treatment process was released into about an acre near the western site boundary (Cellon blowdown area). In 1963, a pole washing unit was installed in the northern portion of the plant site. From 1963 through 1973, equipment was used to spray a solution of water and sodium hydroxide on the Cellon-treated poles to both remove excess pentachlorophenol (PCP) from the pole surface and to prevent formation of PCP crystals on the wood surface. Wastewater from the process was not contained, and much of this wastewater flowed to a small depression just south of the pole washer.

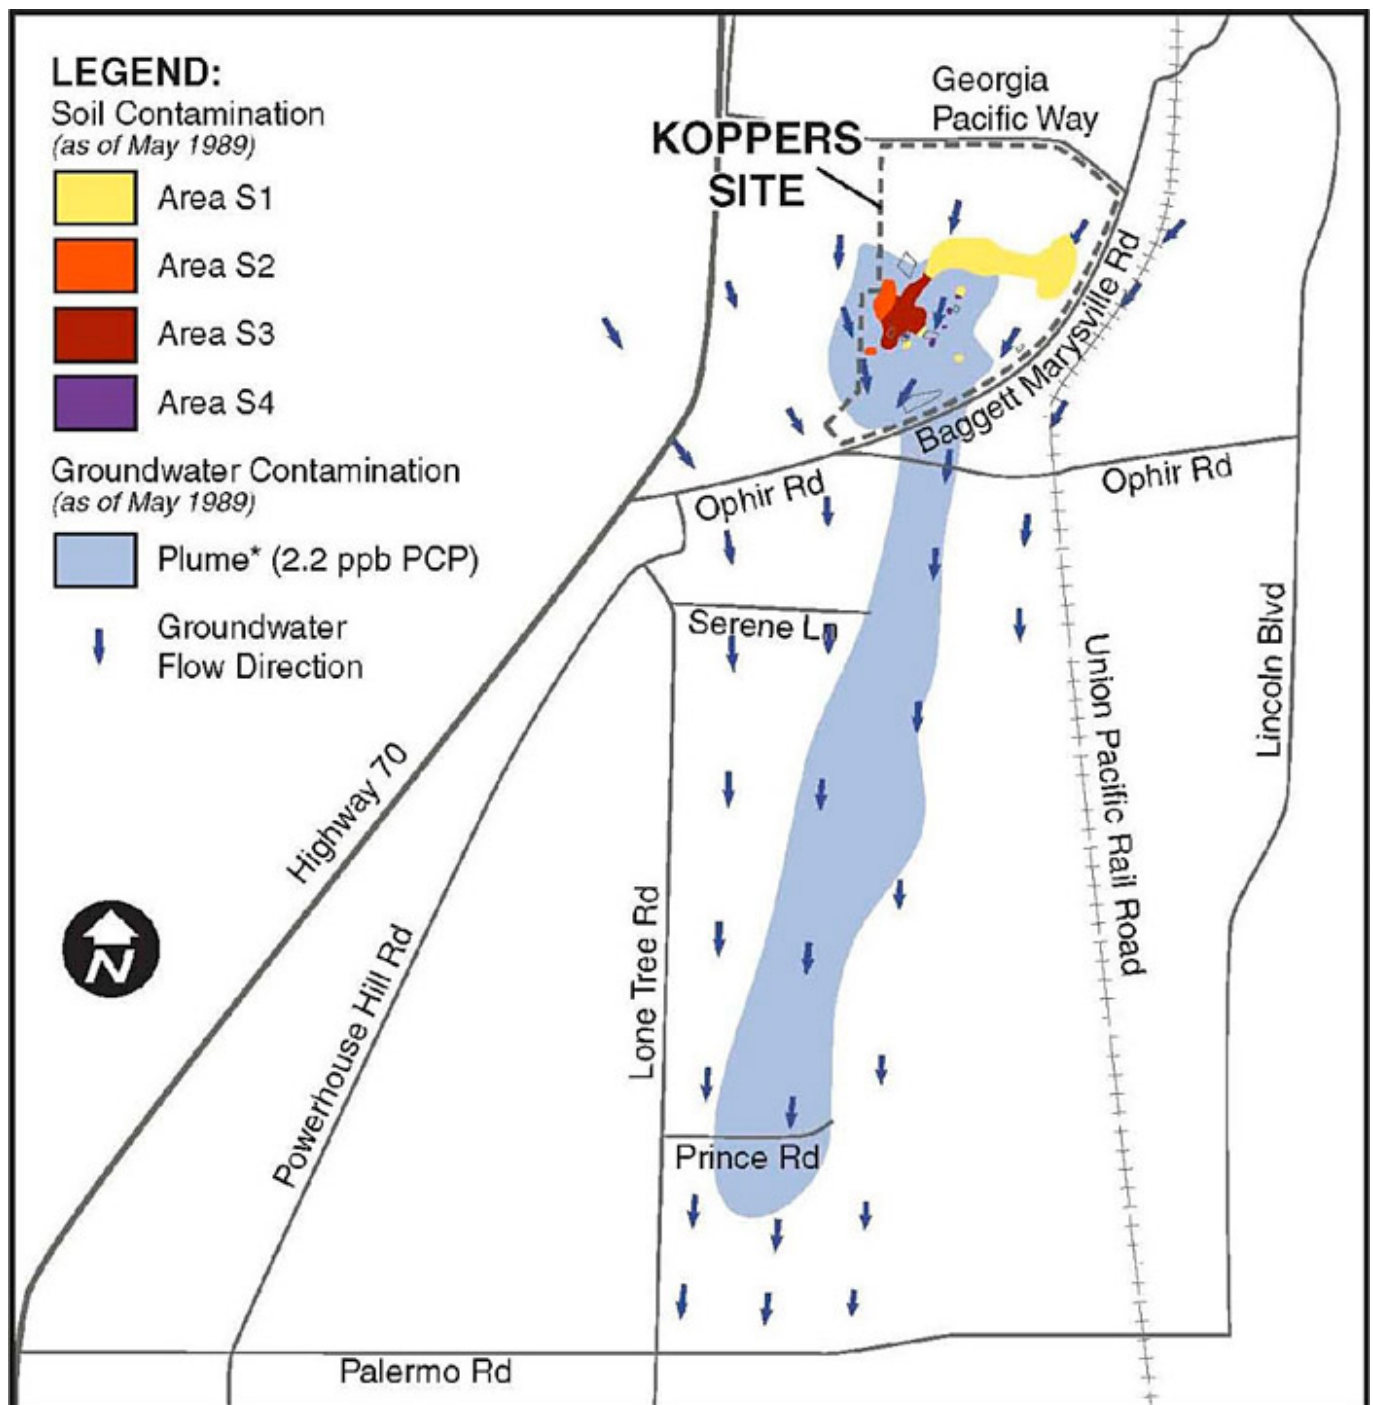
Figure 8. Soil and groundwater units, former Koppers Oroville Wood Treatment Facility (USEPA 2013a).

The remedy for the site was described in the original 1989 ROD, 1991 ESD, and ROD Amendments 1 and 2 (1996 and 1999). Four soil operable units, OU S1 through OU S4 were designated (Figure 8), as well as two groundwater units: on-property and off-property. Cleanup standards for soil were based on direct contact with surface soil and were set to residential standards. The ESD provided separate cleanup standards for subsurface soil to protect underlying groundwater. Cleanup goals for groundwater were established as MCLs for PCP, total carcinogenic PAHs, dioxins/furans, and background levels for arsenic

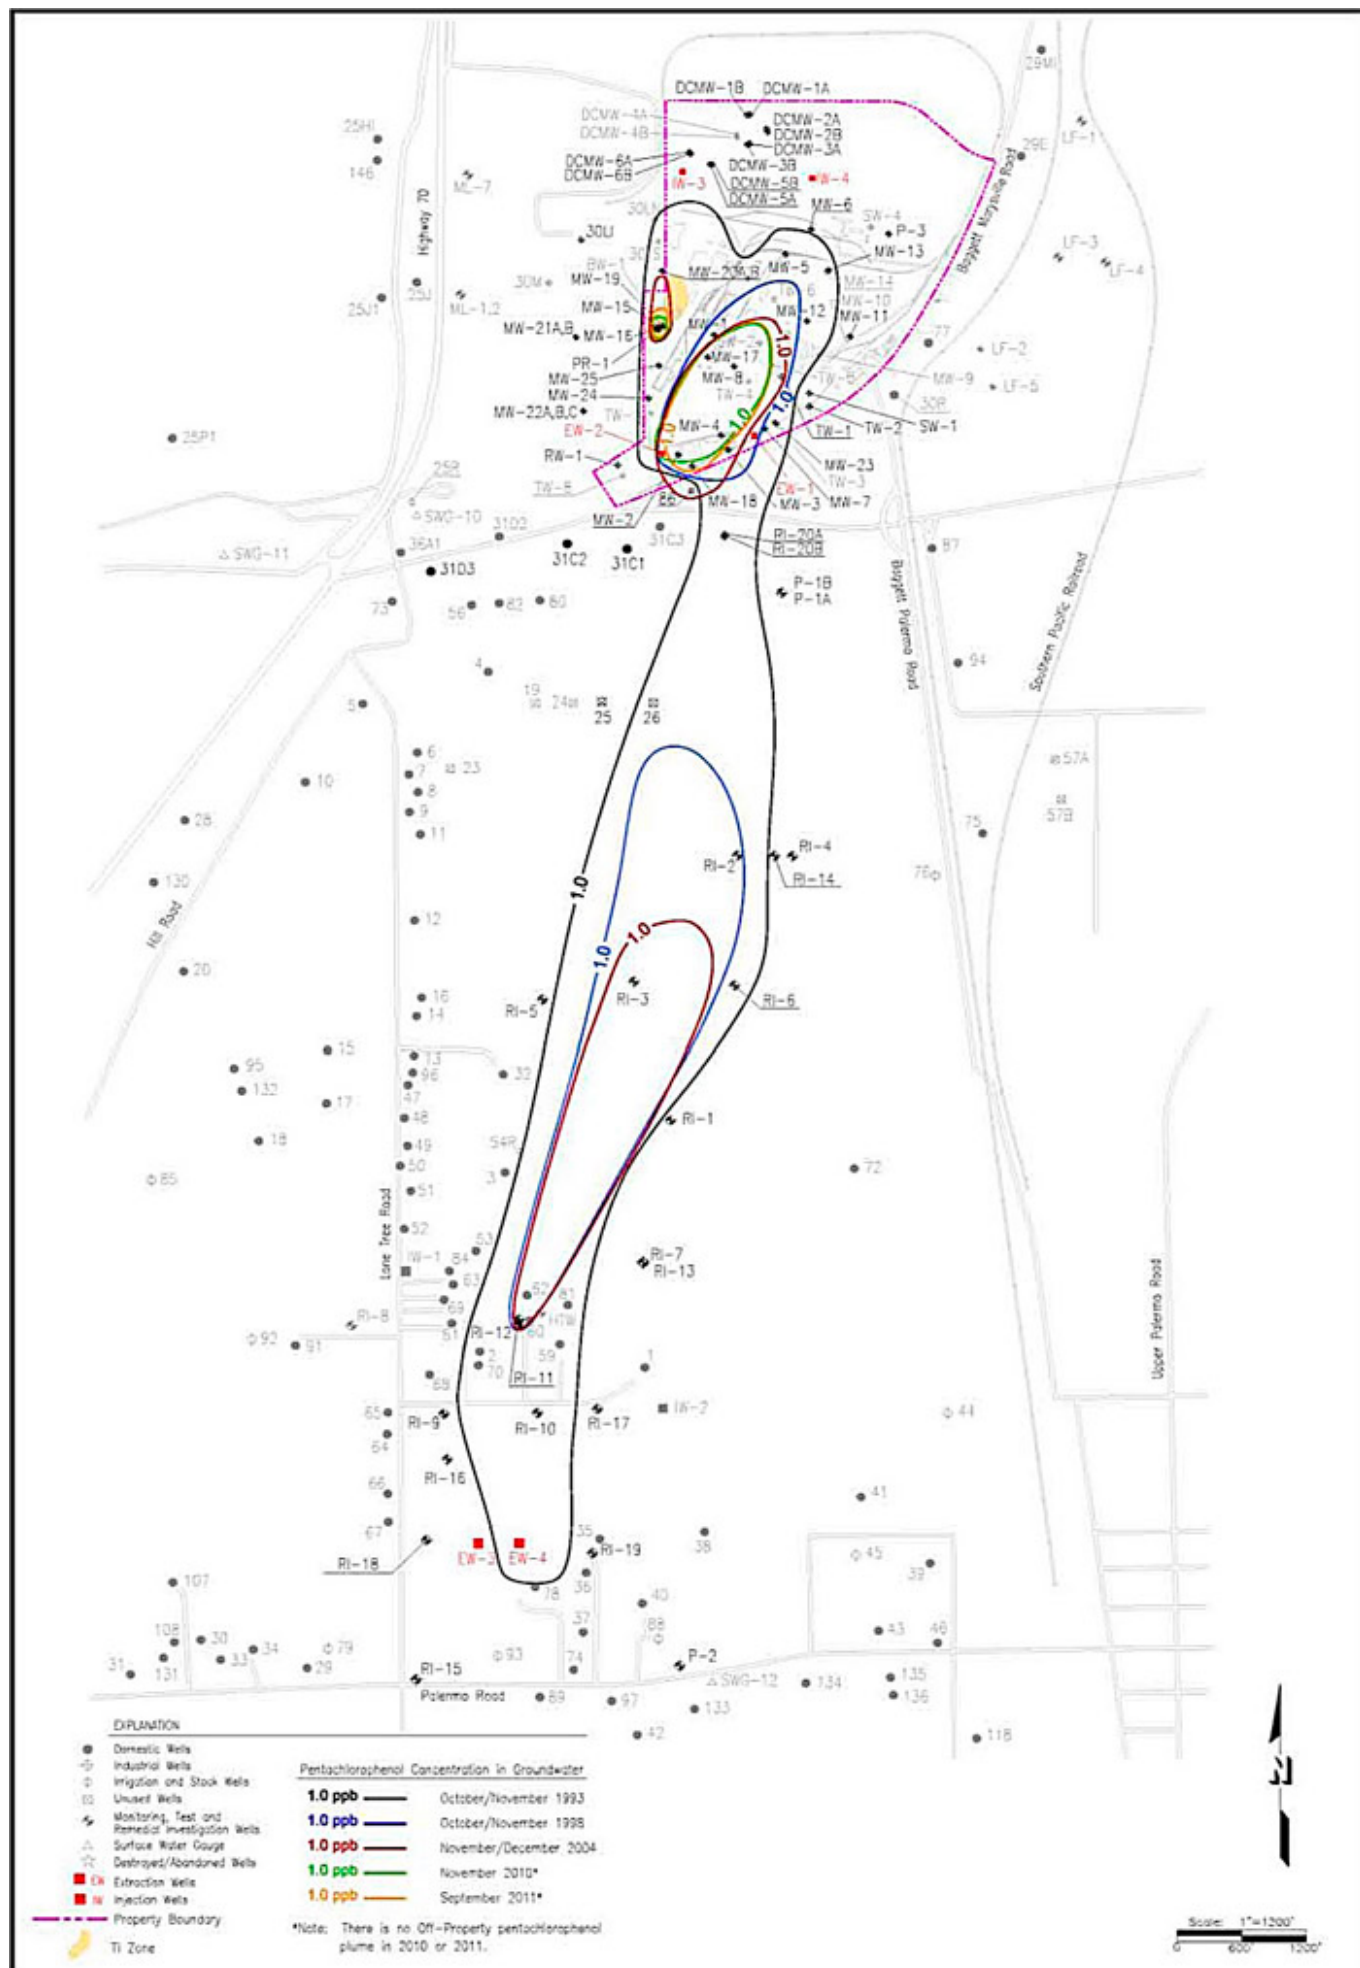
Figure 9. On property and off property PCP plume, comparison from 1993 through 2011 for the former Koppers Oroville Wood Treatment Facility
(USEPA 2013a)

An off-property groundwater treatment system was installed south of Prince Road (Figure 9). Two extraction wells (EW-3 and EW-4) were installed at the toe of the two-mile plume (Figure 9) along with a treatment plant, two injection wells, and approximately 1,500 feet of pipelines. Initially, treated water was discharged to Wyman Ravine. Later, this water was reinjected upgradient of the off-property plume into injection wells IW-1 and IW-2. The P&T system was shut down in December 1995 and dismantled in 2007, after monitoring indicated that the plume had retreated upgradient of the extraction wells. During its operation, the system treated over 626 million gallons of contaminated groundwater.
