Printed from: Interstate Technology & Regulatory Council (ITRC). 2017. *Remediation Management of Complex Sites*. RMCS-1. Washington, D.C.: Interstate Technology & Regulatory Council, Remediation Management of Complex Sites Team. <http://rmcs-1.itrcweb.org>.

6.1 Koppers Oroville Wood Treatment Facility, California

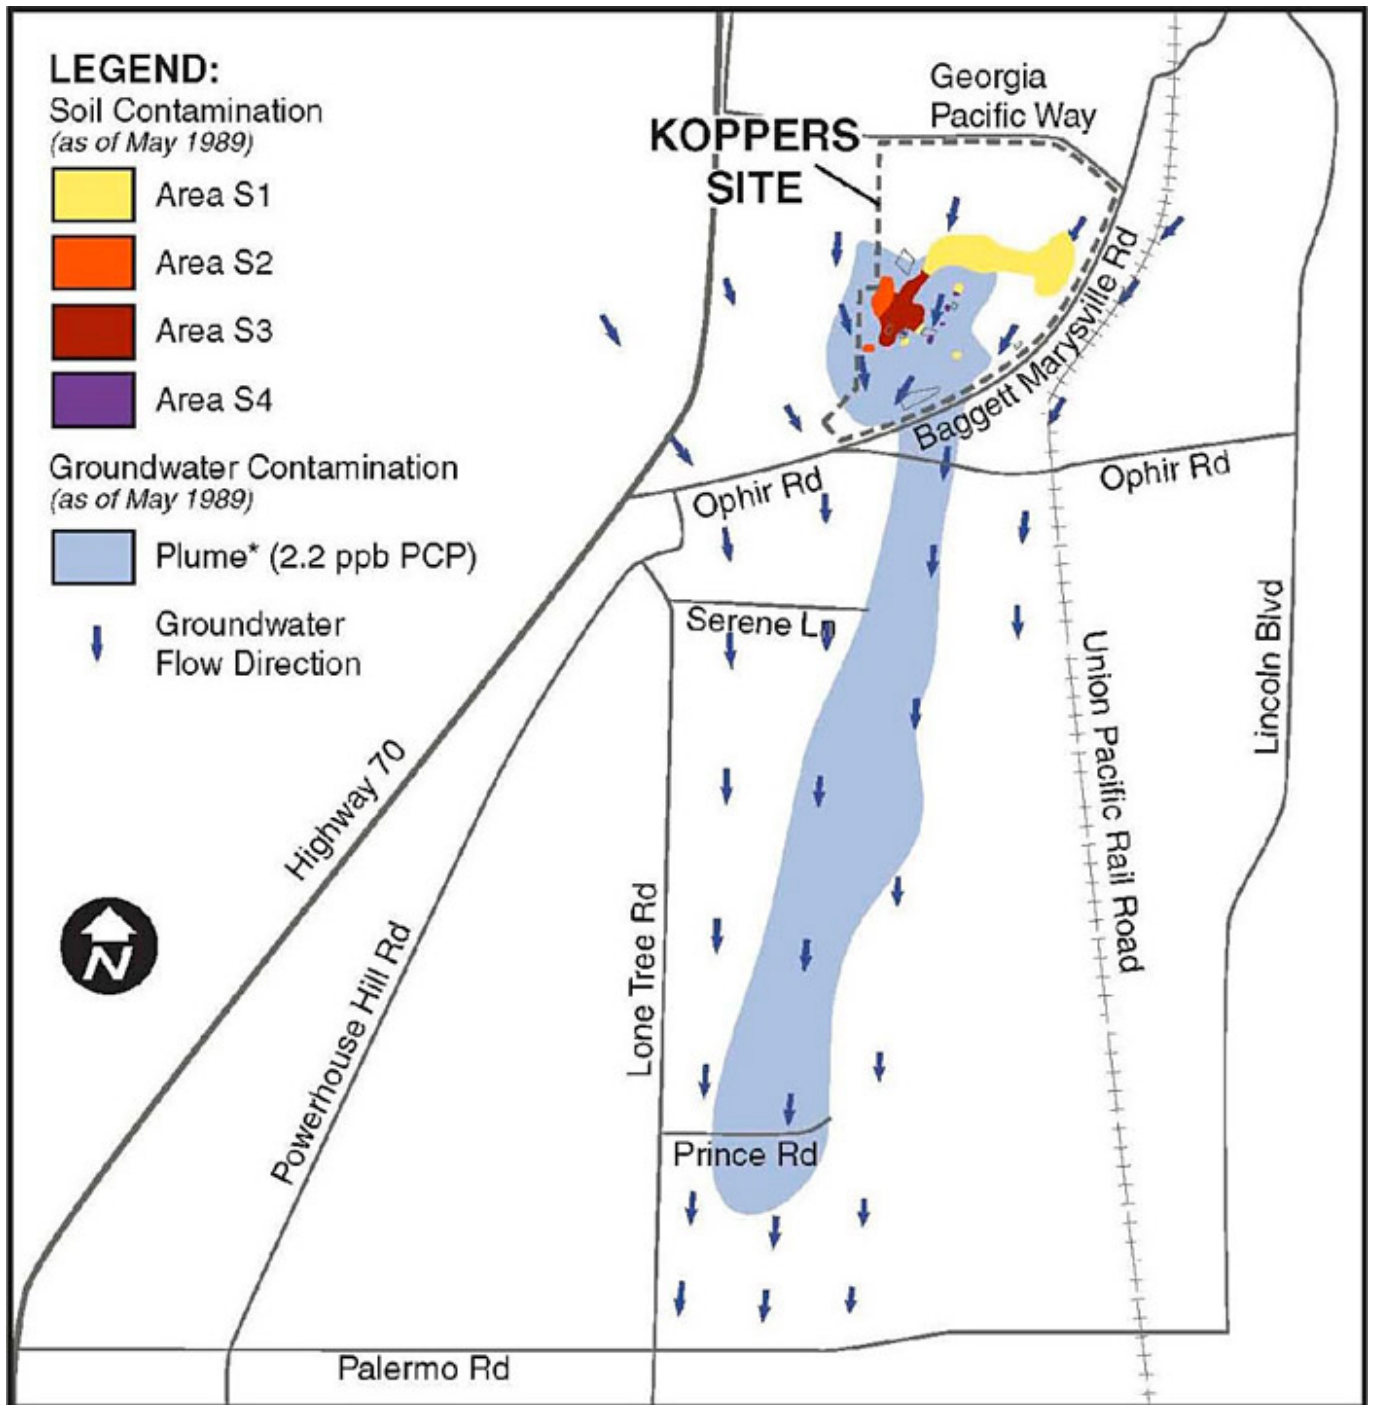
Figure 8. Soil and groundwater units, former Koppers Oroville Wood Treatment Facility (USEPA 2013a).

Four soil operable units, OU S1 through OU S4 were designated (Figure 8), as well as two groundwater units: on-property and off-property. Cleanup standards for soil were based on direct contact with surface soil and were set to residential standards. The ESD provided separate cleanup standards for subsurface soil to protect underlying groundwater. Cleanup goals for groundwater were established as MCLs for PCP, total carcinogenic PAHs, dioxins/furans, and background levels for arsenic and chromium.

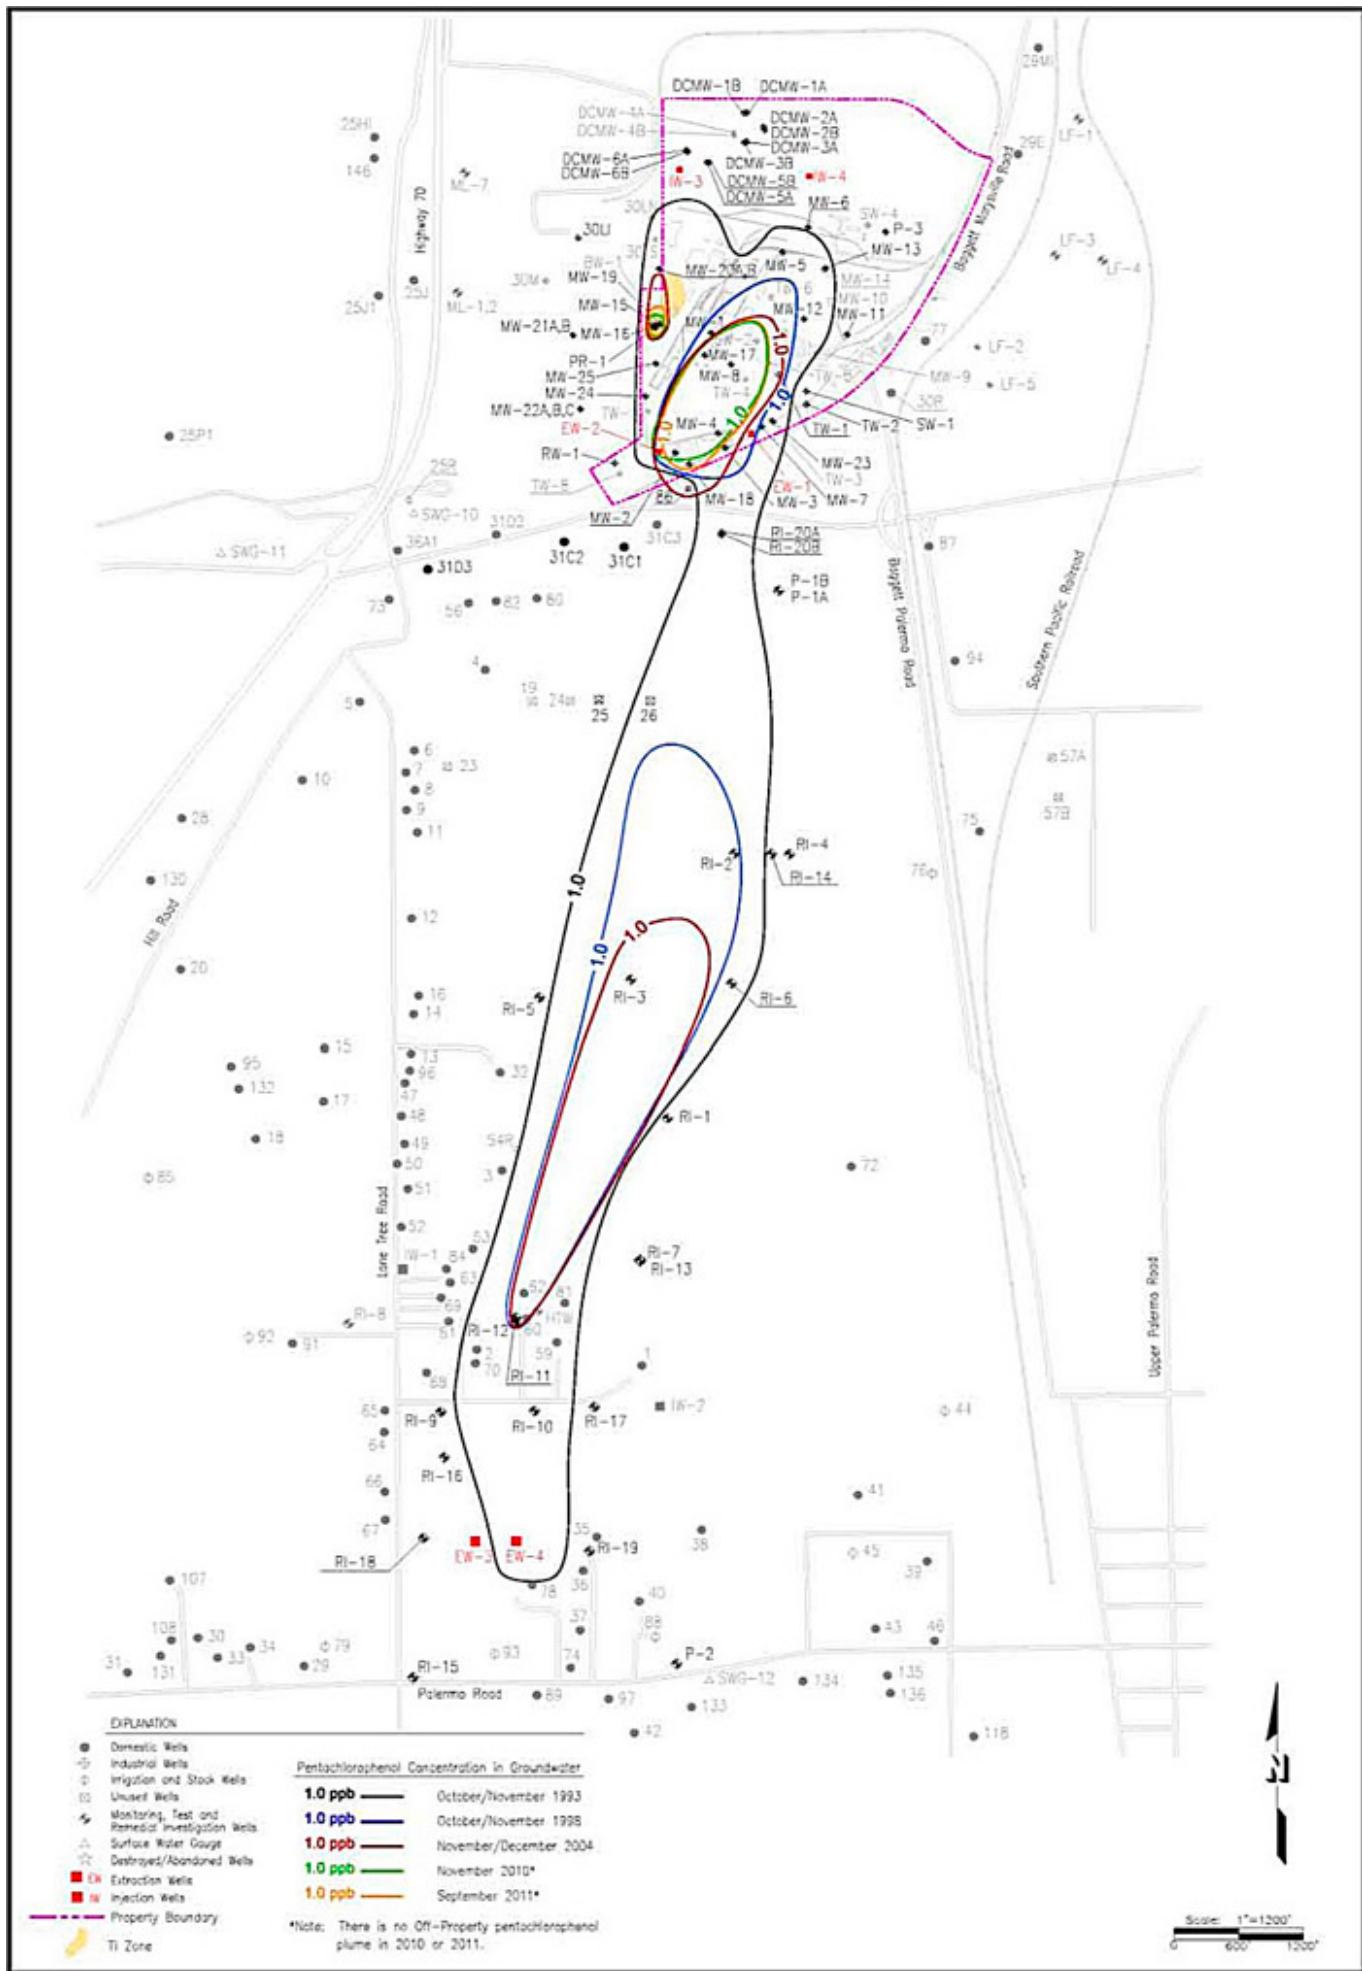
Figure 9. On property and off property PCP plume, comparison from 1993 through 2011 for the former Koppers Oroville Wood Treatment Facility
(USEPA 2013a)

An off-property groundwater treatment system was installed south of Prince Road (Figure 9). Two extraction wells (EW-3 and EW-4) were installed at the toe of the two-mile plume (Figure 9) along with a treatment plant, two injection wells, and approximately 1,500 feet of pipelines. Initially, treated water was discharged to Wyman Ravine. Later, this water was reinjected upgradient of the off-property plume into injection wells IW-1 and IW-2. The P&T system was shut down in December 1995 and dismantled in 2007, after monitoring indicated that the plume had retreated upgradient of the extraction wells. During its operation, the system treated over 626 million gallons of contaminated groundwater.
