## 6.10 Velsicol Chemical, Michigan

### 6.10.1 Technical Basis for Remedial Action

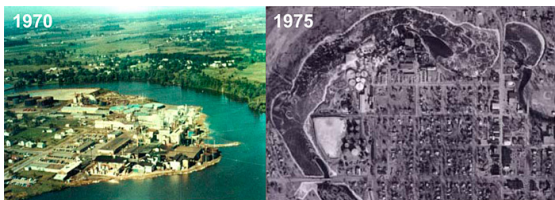
**Figure 45. Aerial photographs of the Velsicol Chemical site** ([Pine River Citizen Task Force 2017](#), [E2 Inc. 2004](#)).

Figure 45 shows local and regional connectivity around the Velsicol Chemical site and its proximity to the Pine River, a natural resource that serves as a vital economic and recreational hub. Figure 45 and Figure 46 demonstrate the proximity of the site to the heart of the community and its historical interaction with the Pine River.

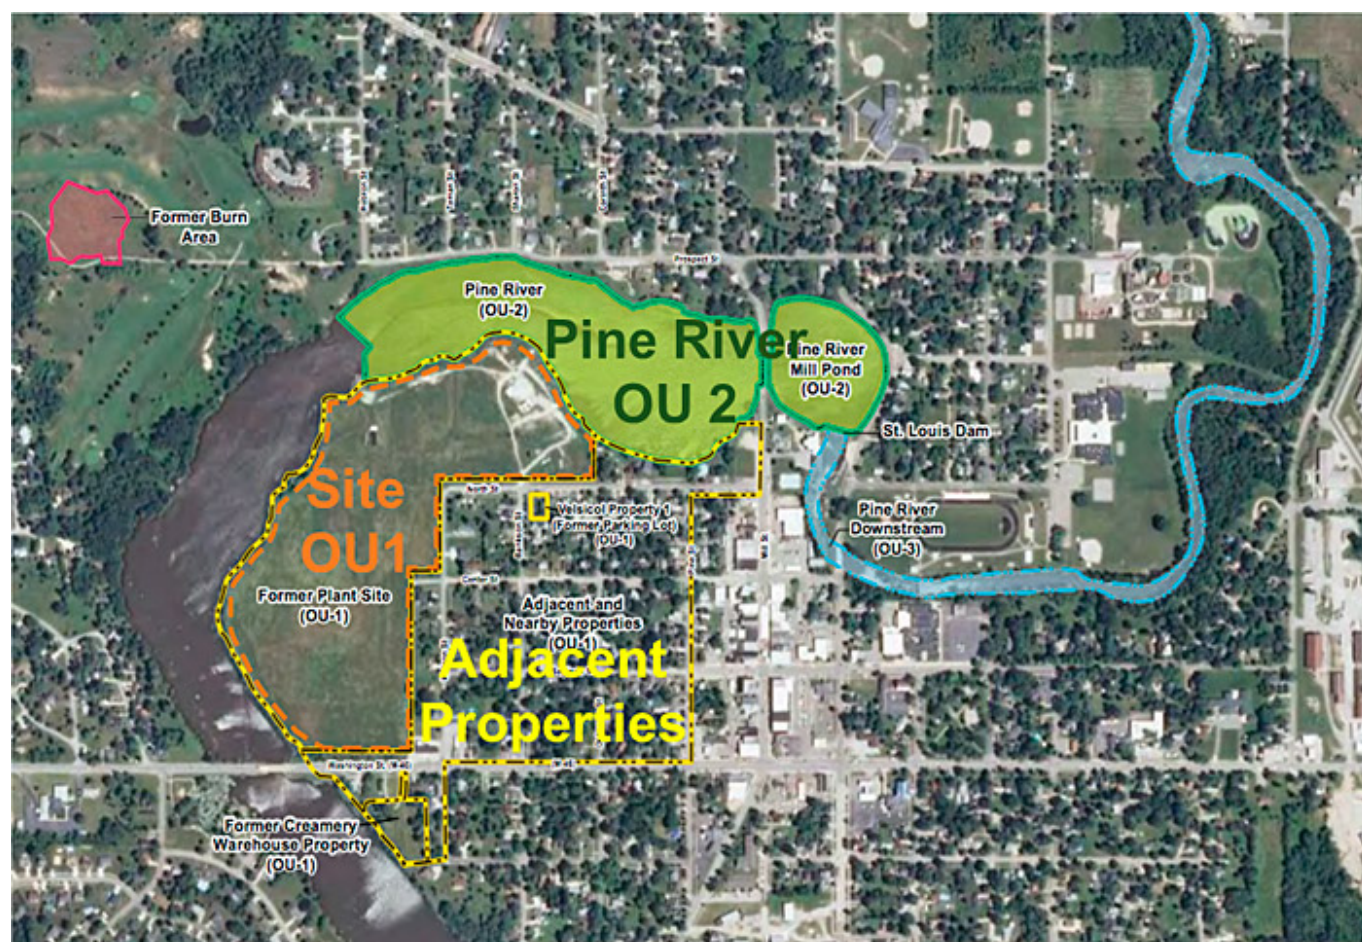
**Figure 46. Velsicol Chemical Site OU 1, OU2 and adjacent or nearby properties in 2002**  
(modified from Heidlauf 2017).

The former plant site and adjacent and nearby residential properties are both included in OU 1. Nearby properties are separated from the site by a fence. Some of the residential properties had direct contact exceedances for the site chemicals. DDT was present in the residential soils at concentrations high enough to cause acute DDT brain poisoning in robins. Green areas illustrate areas where contaminated sediments were addressed as OU2. Downstream of OU2 is the Pine River Downstream OU 3 (shown in blue on Figure 46), where ecological risk assessment and studies were conducted. The red area in the northwest corner of Figure 46 shows the Former Burn Area, where chemical production wastes from the site was incinerated using open air burning. The Former Burn Area is now a separate Superfund site.

Two other related sites not shown on Figure 46 received wastes from the site through illegal disposal. These include farmland south of St. Louis, Michigan, in Bethany Township now known as Gratiot County Landfill and a property in Breckenridge, a small community east of St. Louis. Gratiot County Landfill received PBB waste, other plant-derived wastes, and slaughtered livestock. Gratiot County Landfill is now a Superfund site and continues to conduct monitoring, maintenance, and five-year reviews. Velsicol Chemical Corporation disposed of low-level radioactive wastes in shallow burial trenches at the Breckenridge property following then-applicable Atomic Energy Commission requirements. Subsequently, when the Fruit of the Loom Bankruptcy Trust contractor excavated and removed the low-level radioactive compounds following current Nuclear Regulatory Commission requirements, previously unknown and nonpermitted chemical lab wastes

USEPA funded sediment cleanup and removed over 750,000 cubic yards of DDT-contaminated sediment, which was disposed of in an approved off-site landfill. Dry sediment removal was conducted by driving interlocking sheet piling down the center of impoundment zones (shown in green on Figure 46), dividing, and dewatering half of the Pine River and performing sediment removal actions. Once completed, river flow was restored on the remediated side and the other, contaminated, side was dewatered so that dry excavation activities could be completed. As a result, DDT levels in fish tissue decreased by over 98 percent, downstream of the city dam. The state of Michigan plans to keep the fish advisory in place until the entire site has been remediated.

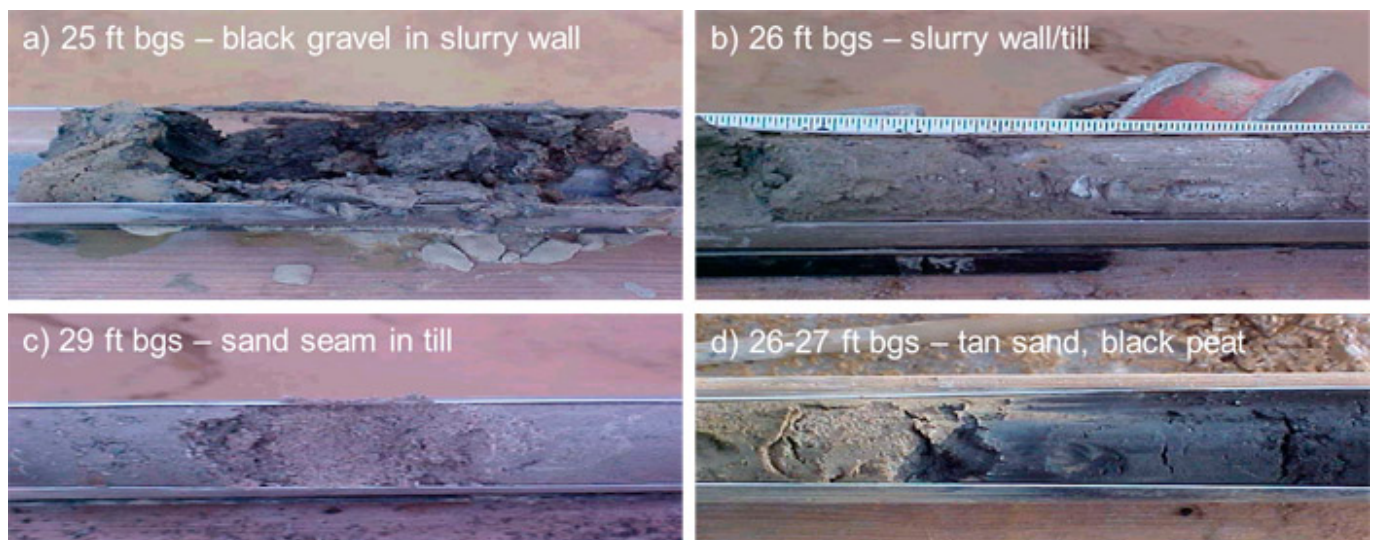
**Figure 47. Boring WPZ-10S and WPZ-11S taken in the slurry wall, illustrating gaps in the wall and variation in slurry placement at different depths below ground surface ([Weston Solutions 2006](#)).**

In addition, the slurry wall was not constructed properly and allowed contaminants to discharge directly off site into the Pine River. Slurry wall boring samples were taken in February 2002; photos are shown in Figure 47 and Figure 48. Slurry was found to not be keyed into the underlying clay layer in some areas; deeper sand and gravel deposits were present beneath the base of the slurry wall in those areas. Gaps in the wall explained the extensive seepage and DNAPL exiting the site into the Pine River.

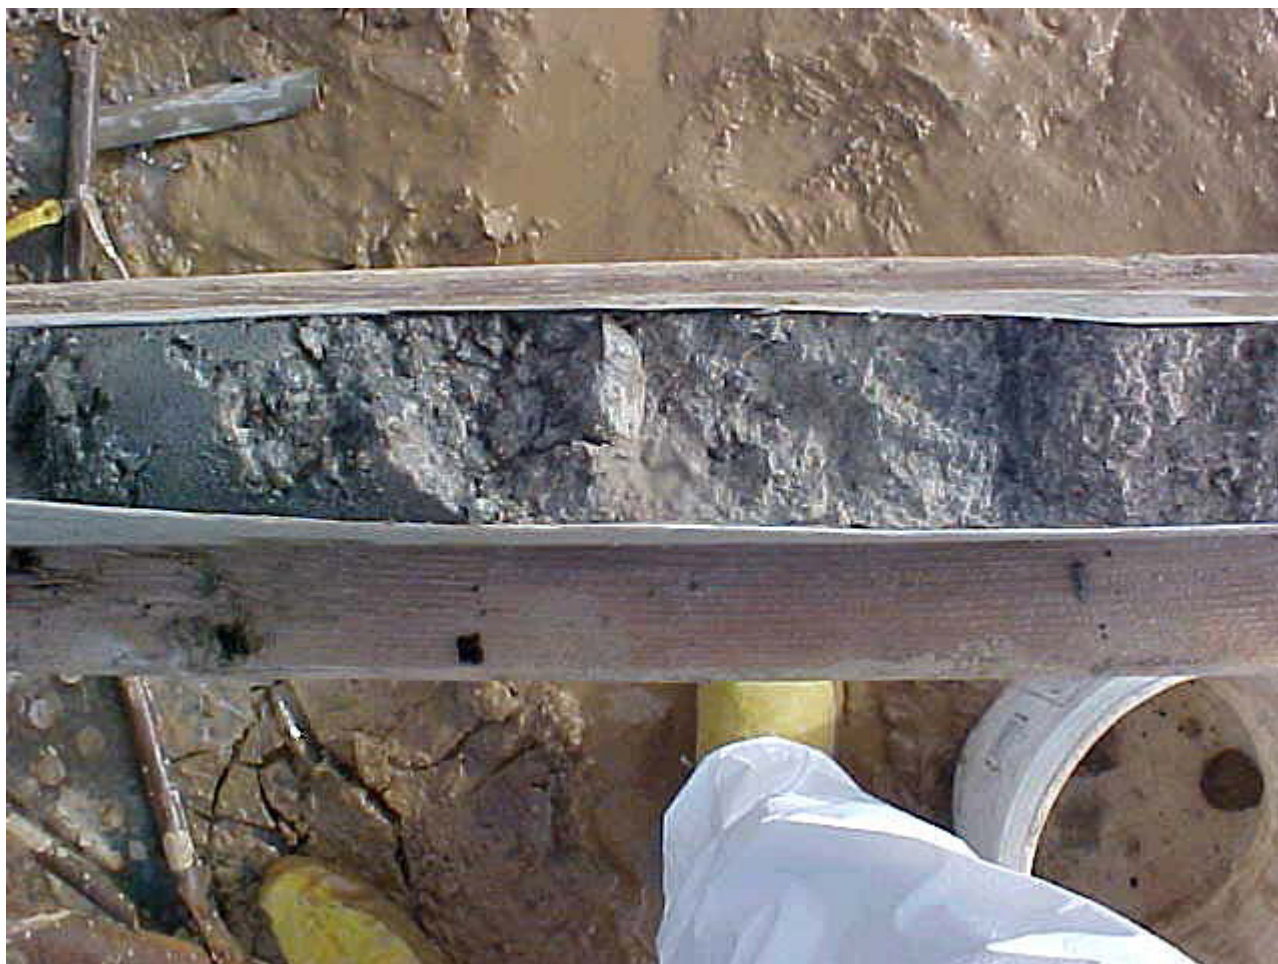
**Figure 48. Boring WPZ-11S from 28-30 ft. bgs, showing the presence of gravel ([Weston Solutions 2006](#)).**

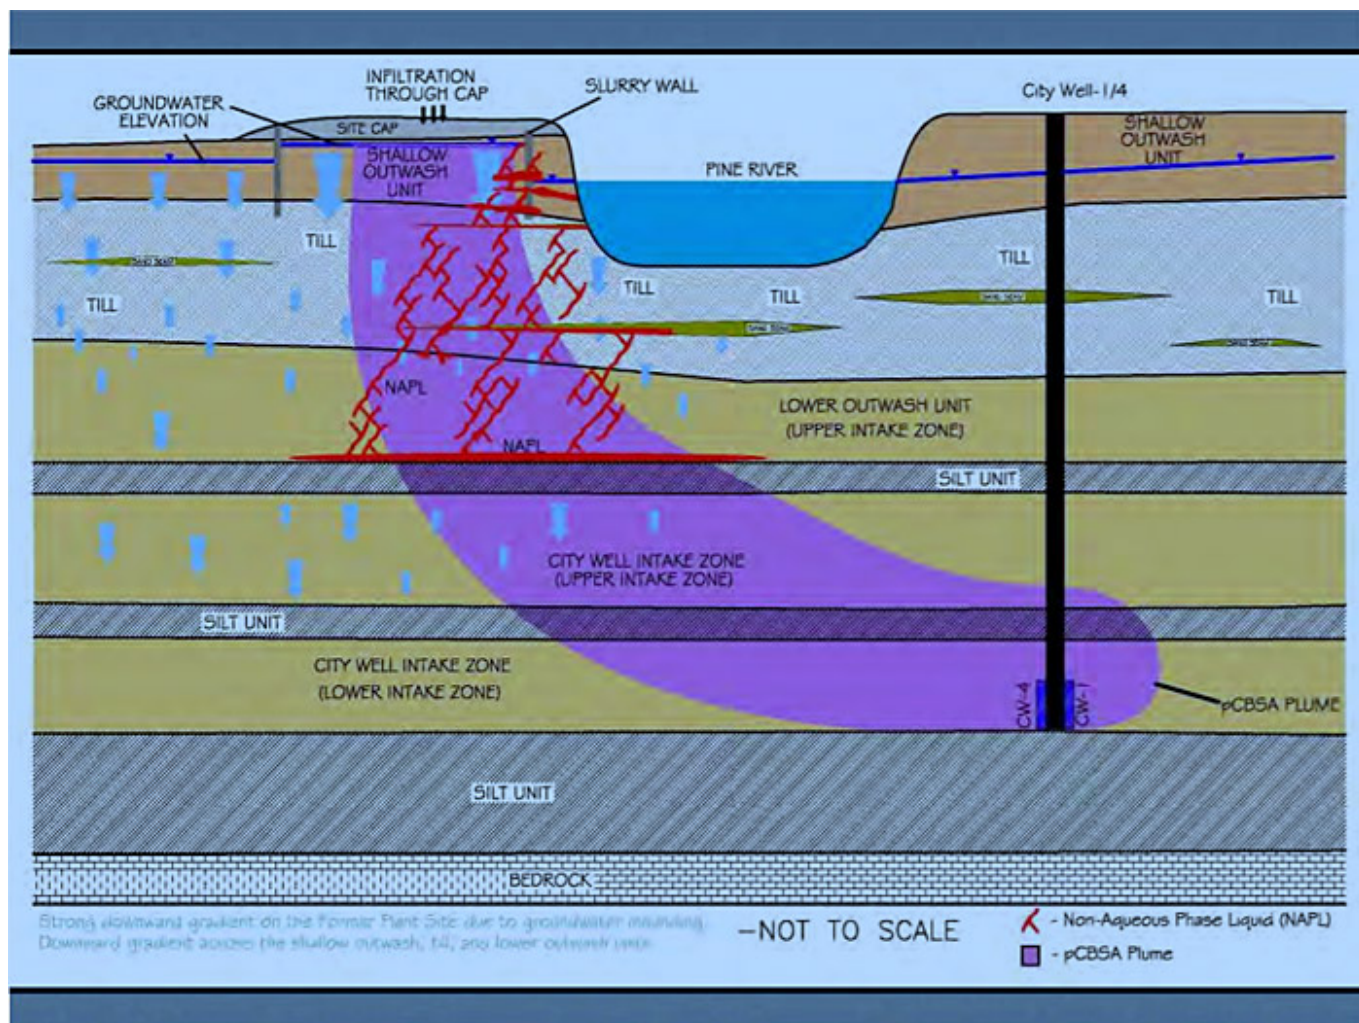
**Figure 49. Conceptual contaminant transport model** (Weston Solutions 2008).

Remedial investigations from 2002 to 2012 identified extensive surface and subsurface contamination including soil and groundwater contamination and extensive NAPL and DNAPL pools. An RI report for OU 1 was finalized in 2006. Soils contained DBCP. Contamination is found in the shallow, intermediate and deep aquifer systems. DNAPL has moved through semiconfining units to a depth of 99 feet below the site at a location adjacent to the Pine River (Figure 49).

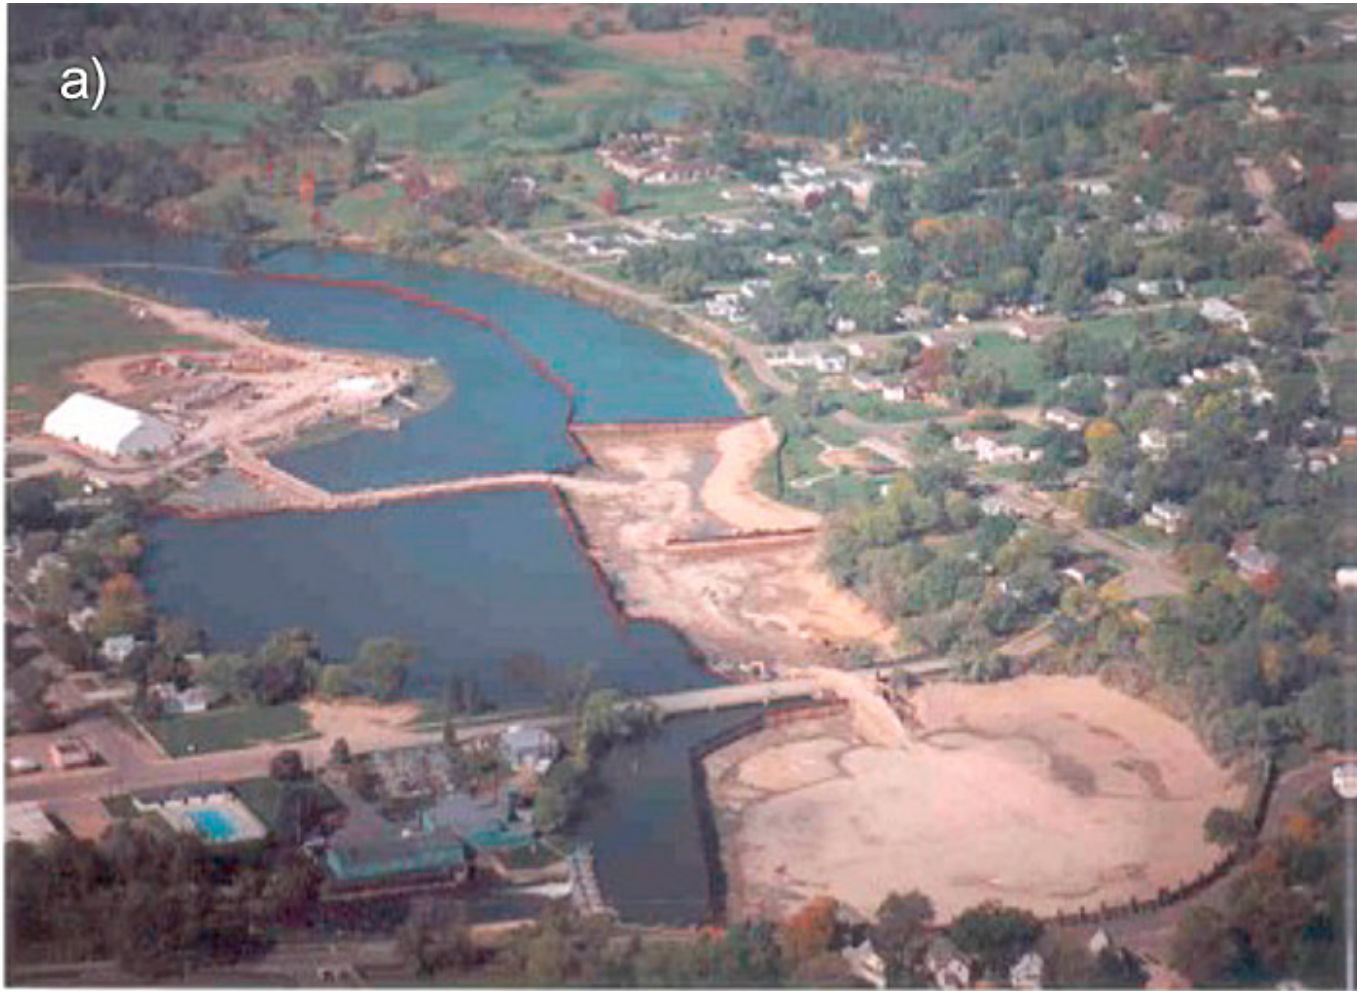
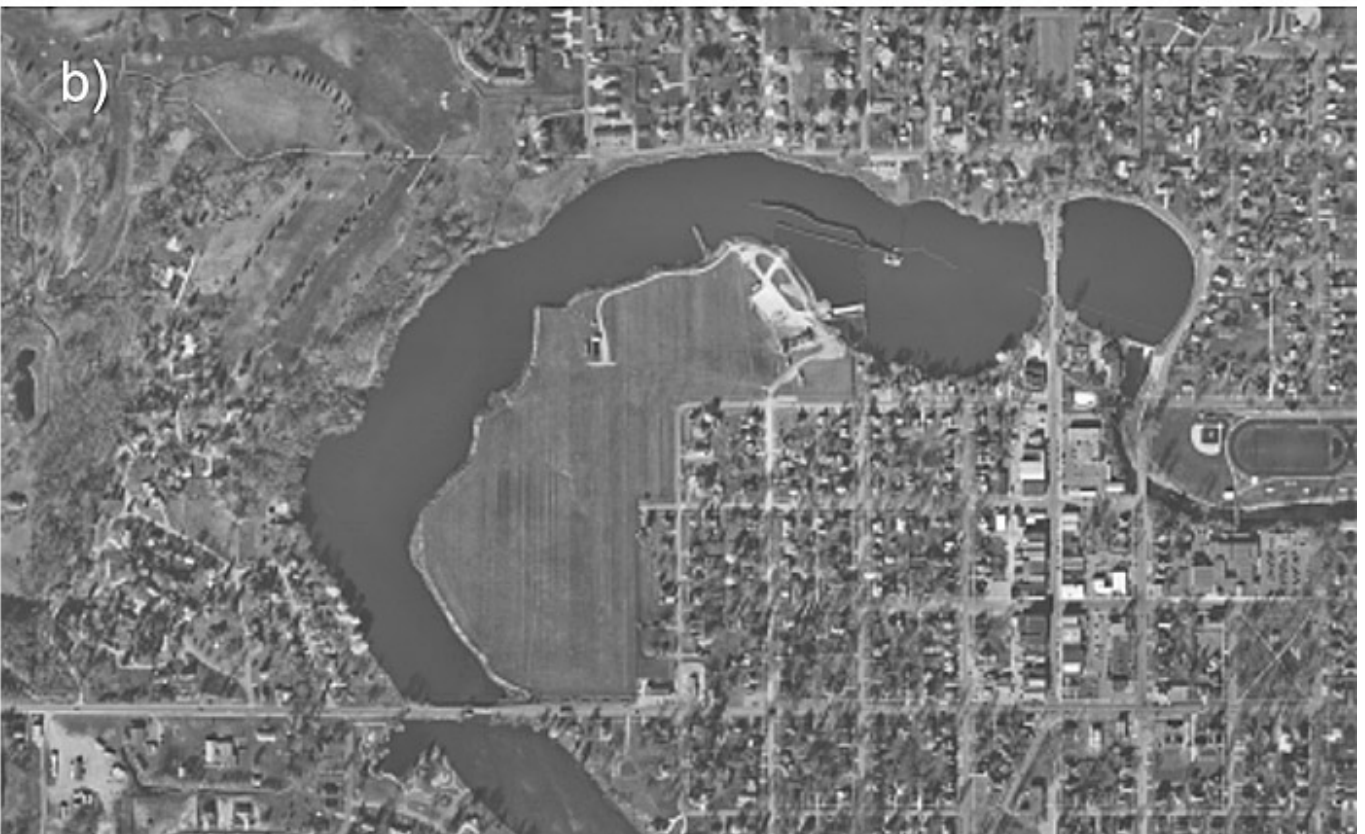
**Figure 51. Aerial photographs of the site a) during sediment removal in 2002 and b) after sediment removal, showing cap cover (E2 Inc. 2004, modified from Heidlauf 2017).**

In response to discovering migration through the slurry wall, USEPA undertook an interim response action in 2002 to prevent recontamination of the Pine River by future migration of DNAPL and contaminated groundwater from the site. Collection trenches were constructed in the top of the till unit underlying sediments along the Pine River shoreline where DNAPL had been observed. In addition to the collection system, a layer of compacted clay at least two feet thick was placed on the till unit to cap areas within the sediment removal cells where DNAPL-impacted till remained (Figure 51).
