## 6.10 Velsicol Chemical, Michigan

### 6.10.1 Technical Basis for Remedial Action

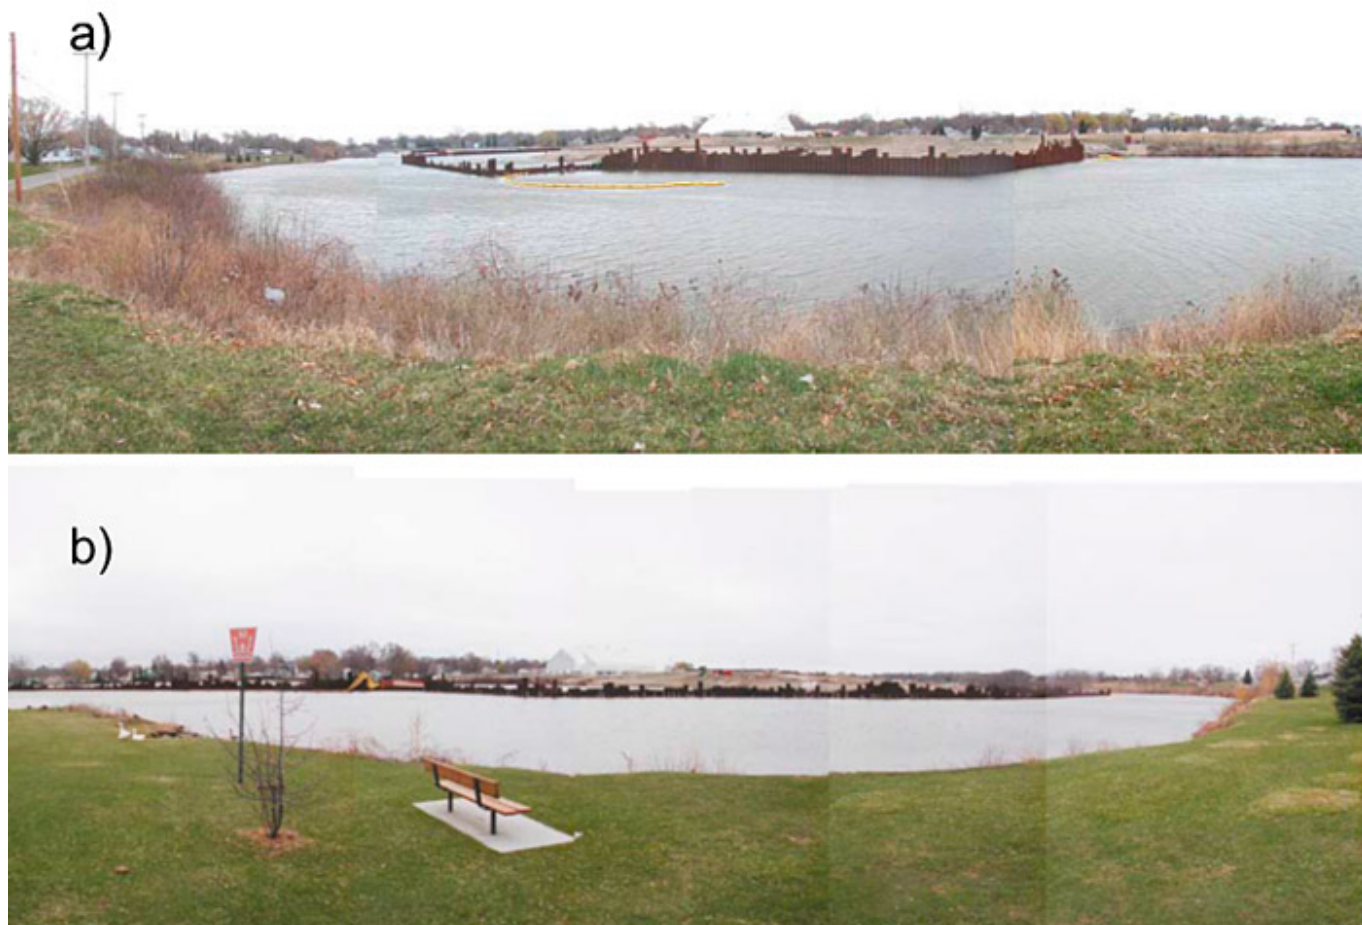
**Figure 50. Views of the site from across the Pine River a) in 2003 and b) in 2004, following the Superfund redevelopment initiative pilot project ([E2 Inc. 2004](#)).**
