## 6.10 Velsicol Chemical, Michigan

### 6.10.1 Technical Basis for Remedial Action

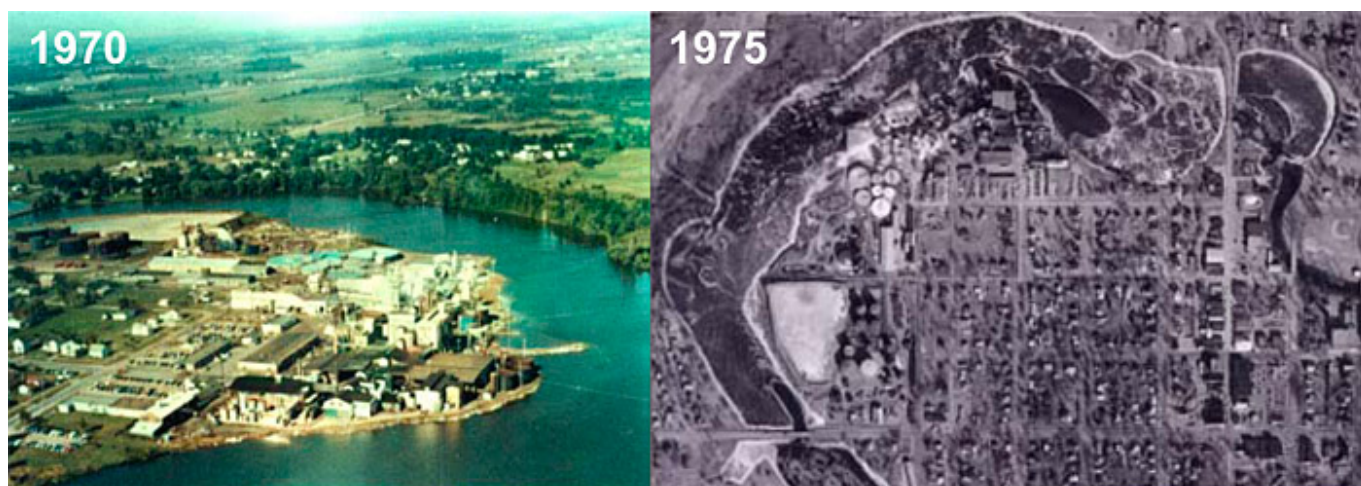
**Figure 45. Aerial photographs of the Velsicol Chemical site** ([Pine River Citizen Task Force 2017](#), [E2 Inc. 2004](#)).

Figure 45 shows local and regional connectivity around the Velsicol Chemical site and its proximity to the Pine River, a natural resource that serves as a vital economic and recreational hub. Figure 45 and Figure 46 demonstrate the proximity of the site to the heart of the community and its historical interaction with the Pine River.

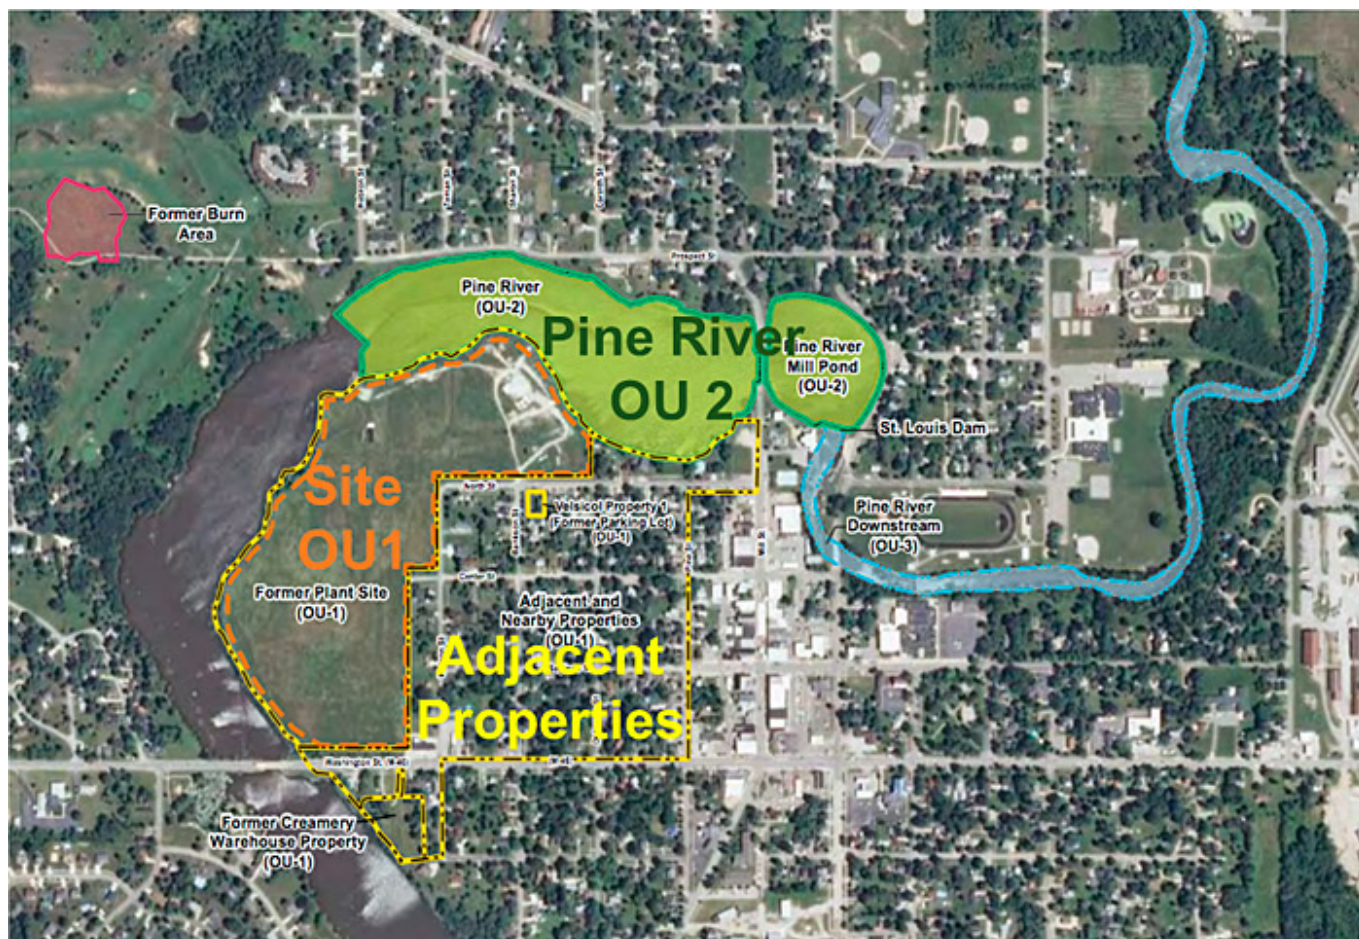
**Figure 46. Velsicol Chemical Site OU 1, OU2 and adjacent or nearby properties in 2002**  
([modified from Heidlauf 2017](#)).

The former plant site and adjacent and nearby residential properties are both included in OU 1. Nearby properties are separated from the site by a fence. Some of the residential properties had direct contact exceedances for the site chemicals. DDT was present in the residential soils at concentrations high enough to cause acute DDT brain poisoning in robins. Green areas illustrate areas where contaminated sediments were addressed as OU2. Downstream of OU2 is the Pine River Downstream OU 3 (shown in blue on Figure 46), where ecological risk assessment and studies were conducted. The red area in the northwest corner of Figure 46 shows the Former Burn Area, where chemical production wastes from the site was incinerated using open air burning. The Former Burn Area is now a separate Superfund site.

USEPA funded sediment cleanup and removed over 750,000 cubic yards of DDT-contaminated sediment, which was disposed of in an approved off-site landfill. Dry sediment removal was conducted by driving interlocking sheet piling down the center of impoundment zones (shown in green on Figure 46), dividing, and dewatering half of the Pine River and performing sediment removal actions. Once completed, river flow was restored on the remediated side and the other, contaminated, side was dewatered so that dry excavation activities could be completed. As a result, DDT levels in fish tissue decreased by over 98 percent, downstream of the city dam. The state of Michigan plans to keep the fish advisory in place until the entire site has been remediated.

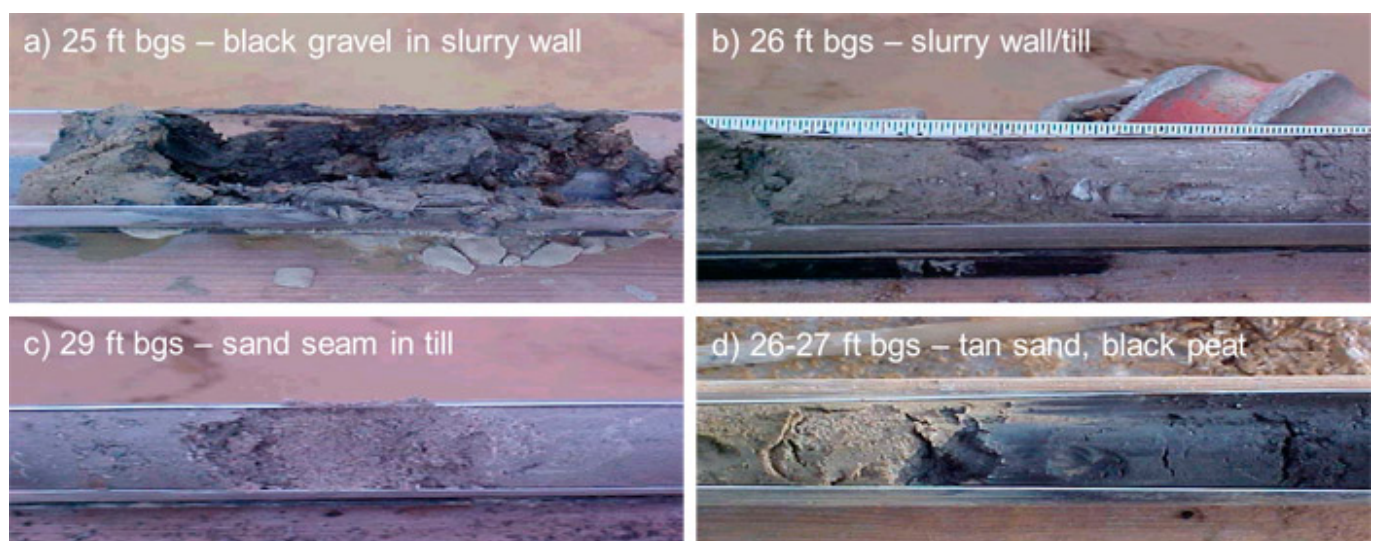
**Figure 47. Boring WPZ-10S and WPZ-11S taken in the slurry wall, illustrating gaps in the wall and variation in slurry placement at different depths below ground surface ([Weston Solutions 2006](#)).**

In addition, the slurry wall was not constructed properly and allowed contaminants to discharge directly off site into the Pine River. Slurry wall boring samples were taken in February 2002; photos are shown in Figure 47 and Figure 48. Slurry was found to not be keyed into the underlying clay layer in some areas; deeper sand and gravel deposits were present beneath the base of the slurry wall in those areas. Gaps in the wall explained the extensive seepage and DNAPL exiting the site into the Pine River.

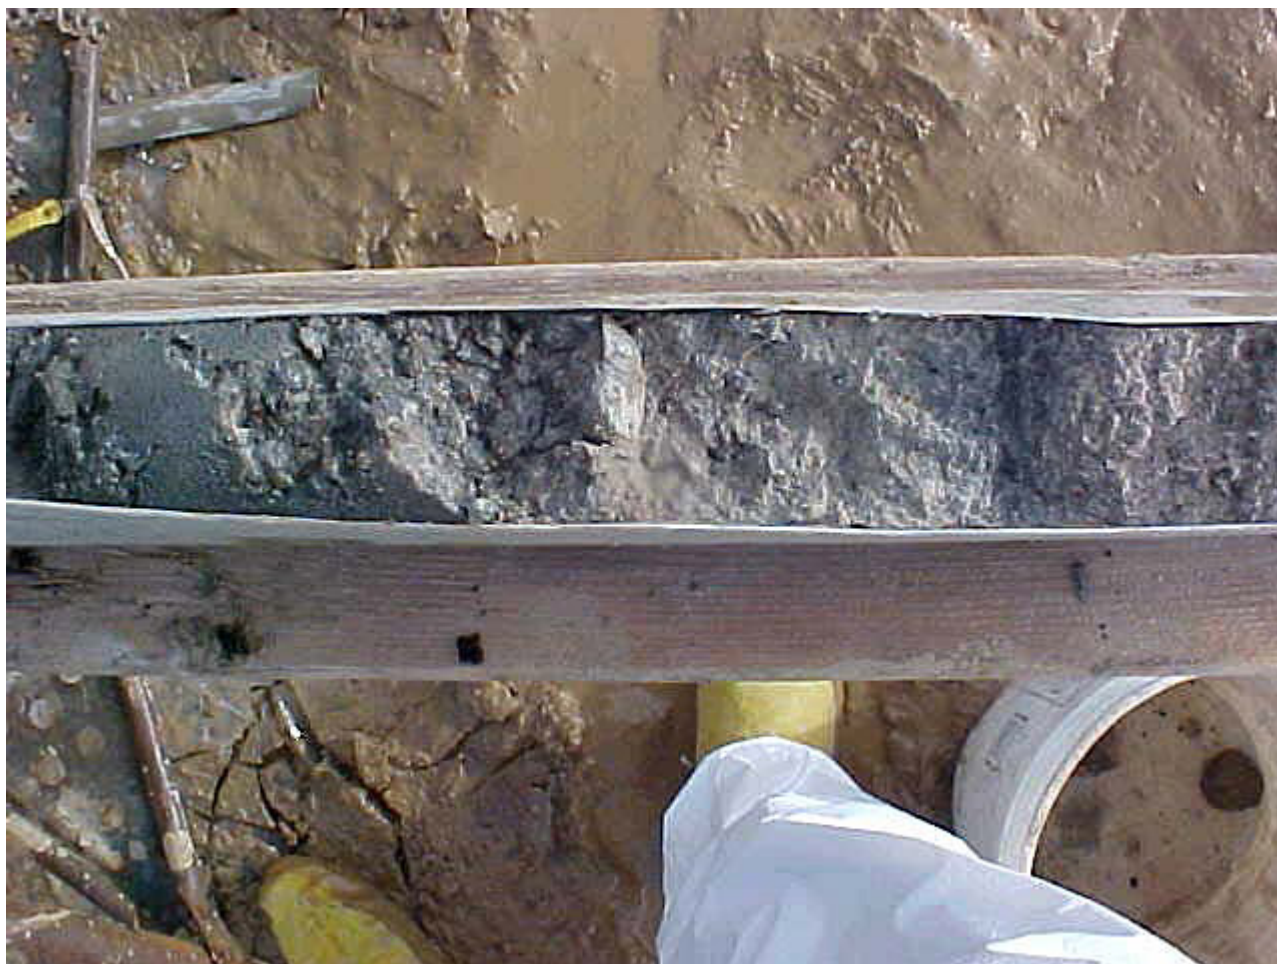
**Figure 48. Boring WPZ-11S from 28-30 ft. bgs, showing the presence of gravel ([Weston Solutions 2006](#)).**

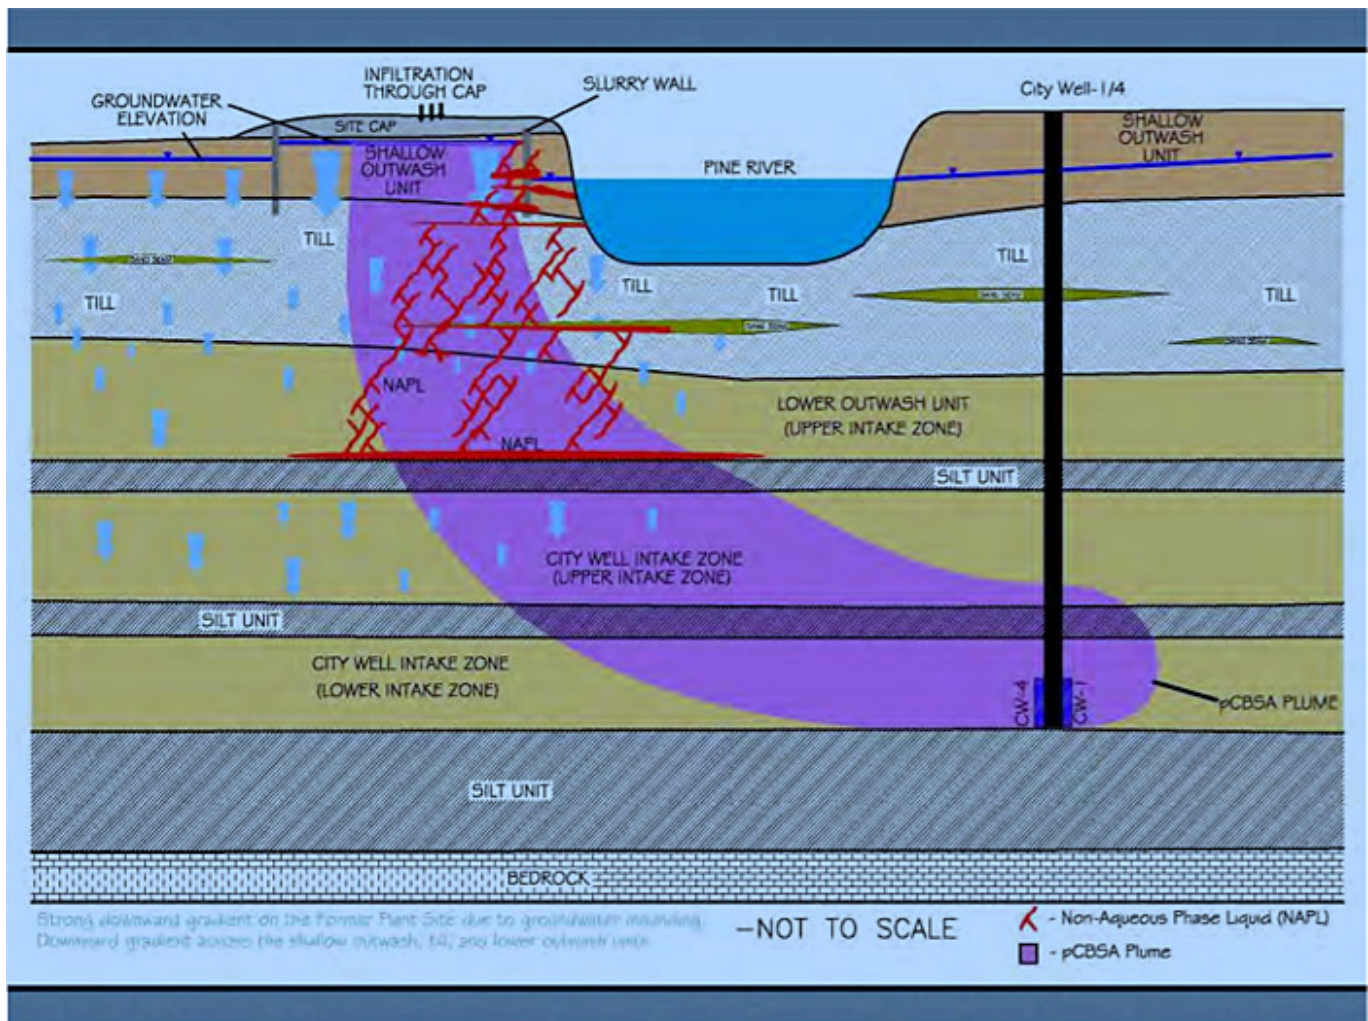
**Figure 49. Conceptual contaminant transport model (Weston Solutions 2008).**

Remedial investigations from 2002 to 2012 identified extensive surface and subsurface contamination including soil and groundwater contamination and extensive NAPL and DNAPL pools. An RI report for OU 1 was finalized in 2006. Soils contained DBCP. Contamination is found in the shallow, intermediate and deep aquifer systems. DNAPL has moved through semiconfining units to a depth of 99 feet below the site at a location adjacent to the Pine River (Figure 49).

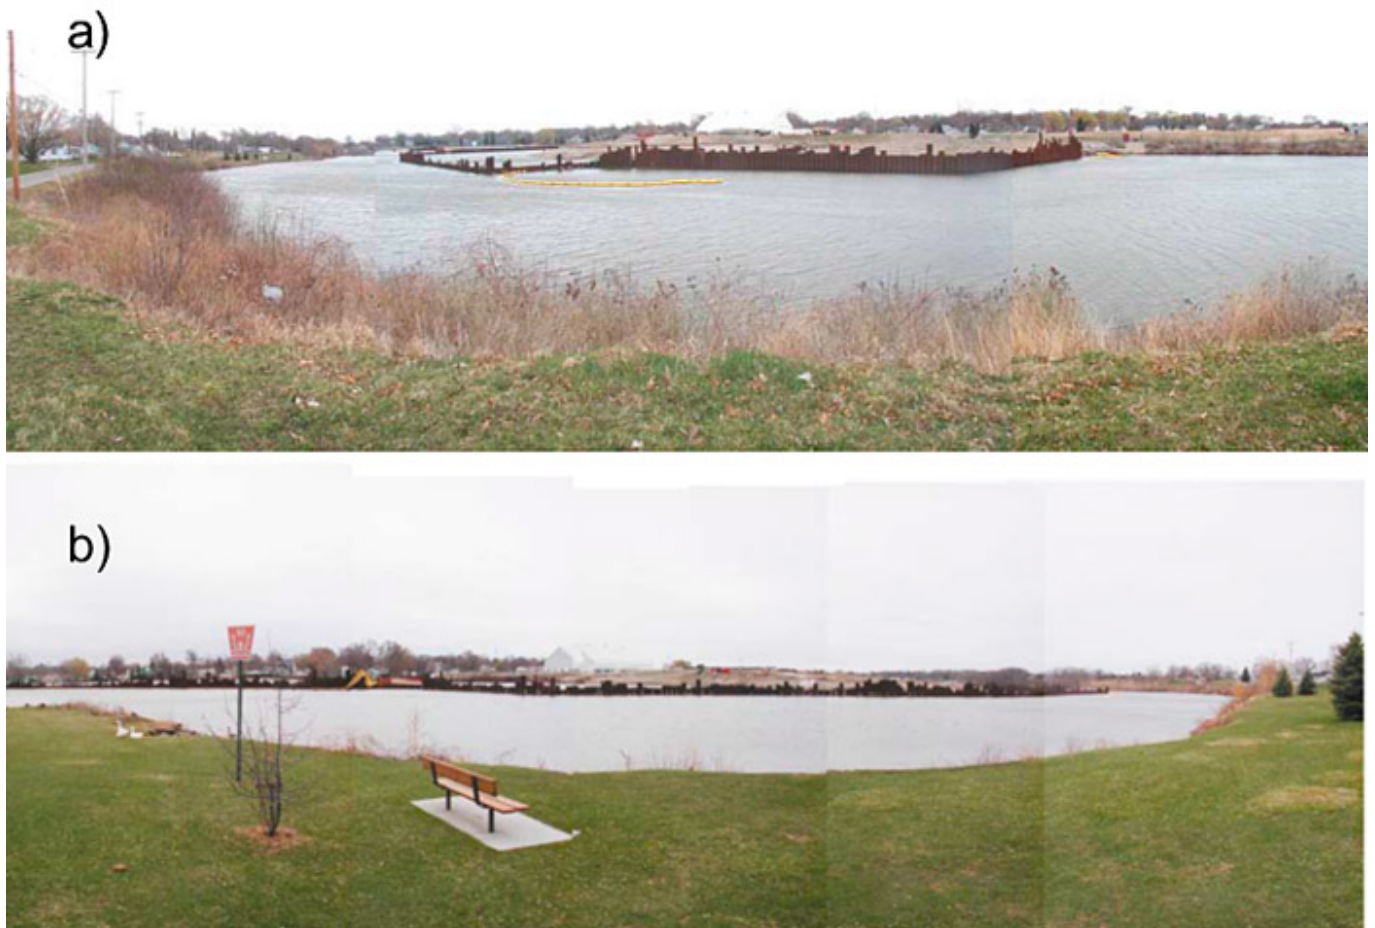
**Figure 50. Views of the site from across the Pine River a) in 2003 and b) in 2004, following the Superfund redevelopment initiative pilot project ([E2 Inc. 2004](#)).**

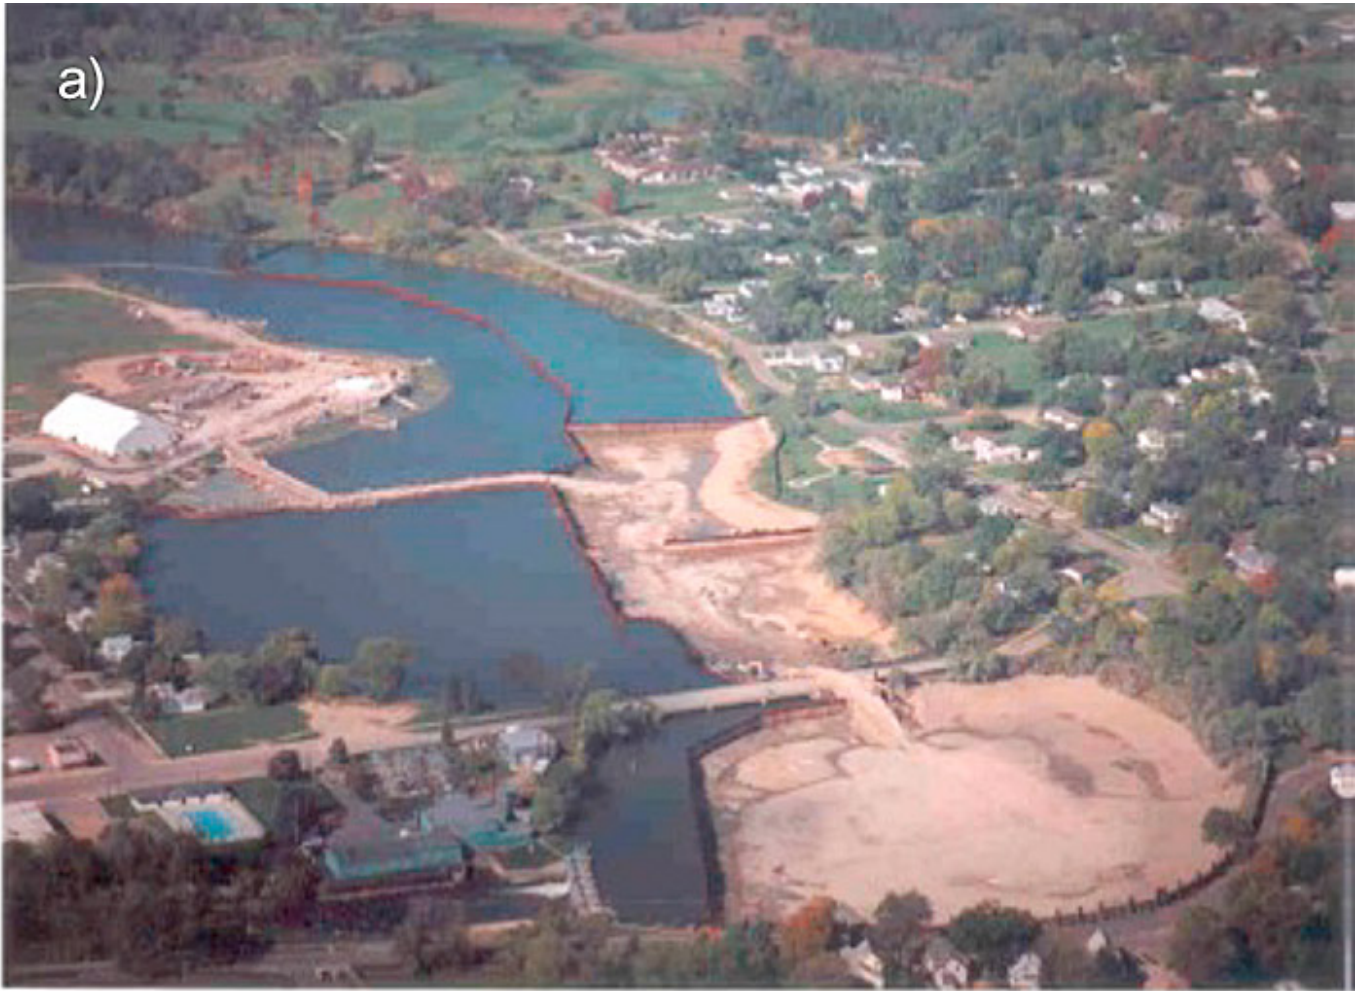
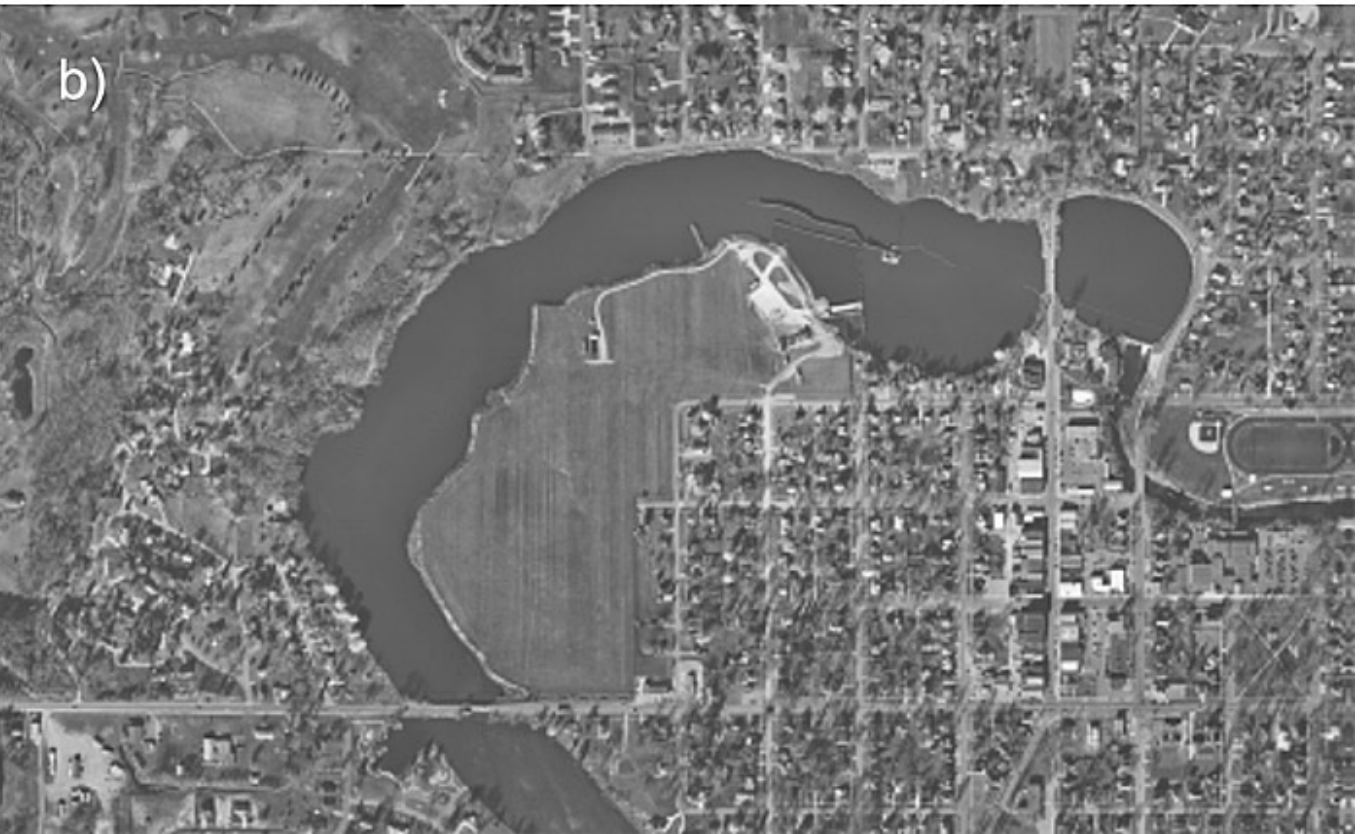
**Figure 51. Aerial photographs of the site a) during sediment removal in 2002 and b) after sediment removal, showing cap cover (E2 Inc. 2004, modified from Heidlauf 2017).**

In response to discovering migration through the slurry wall, USEPA undertook an interim response action in 2002 to prevent recontamination of the Pine River by future migration of DNAPL and contaminated groundwater from the site. Collection trenches were constructed in the top of the till unit underlying sediments along the Pine River shoreline where DNAPL had been observed. In addition to the collection system, a layer of compacted clay at least two feet thick was placed on the till unit to cap areas within the sediment removal cells where DNAPL-impacted till remained (Figure 51).
